Geologic Analysis of the Seal Cove Area

GEOTECHNICAL HAZARDS MAP SEAL COVE STUDY AREA

PLATE NO. 1 SCALE: 1"=200' DATE: 8/5/80
 PROJECT NO. G 112-80 GEO./ENG. BY: [Signature] APPROVED BY: WRC

GEOLOGIC ANALYSIS
OF THE
SEAL COVE AREA
COUNTY OF SAN MATEO

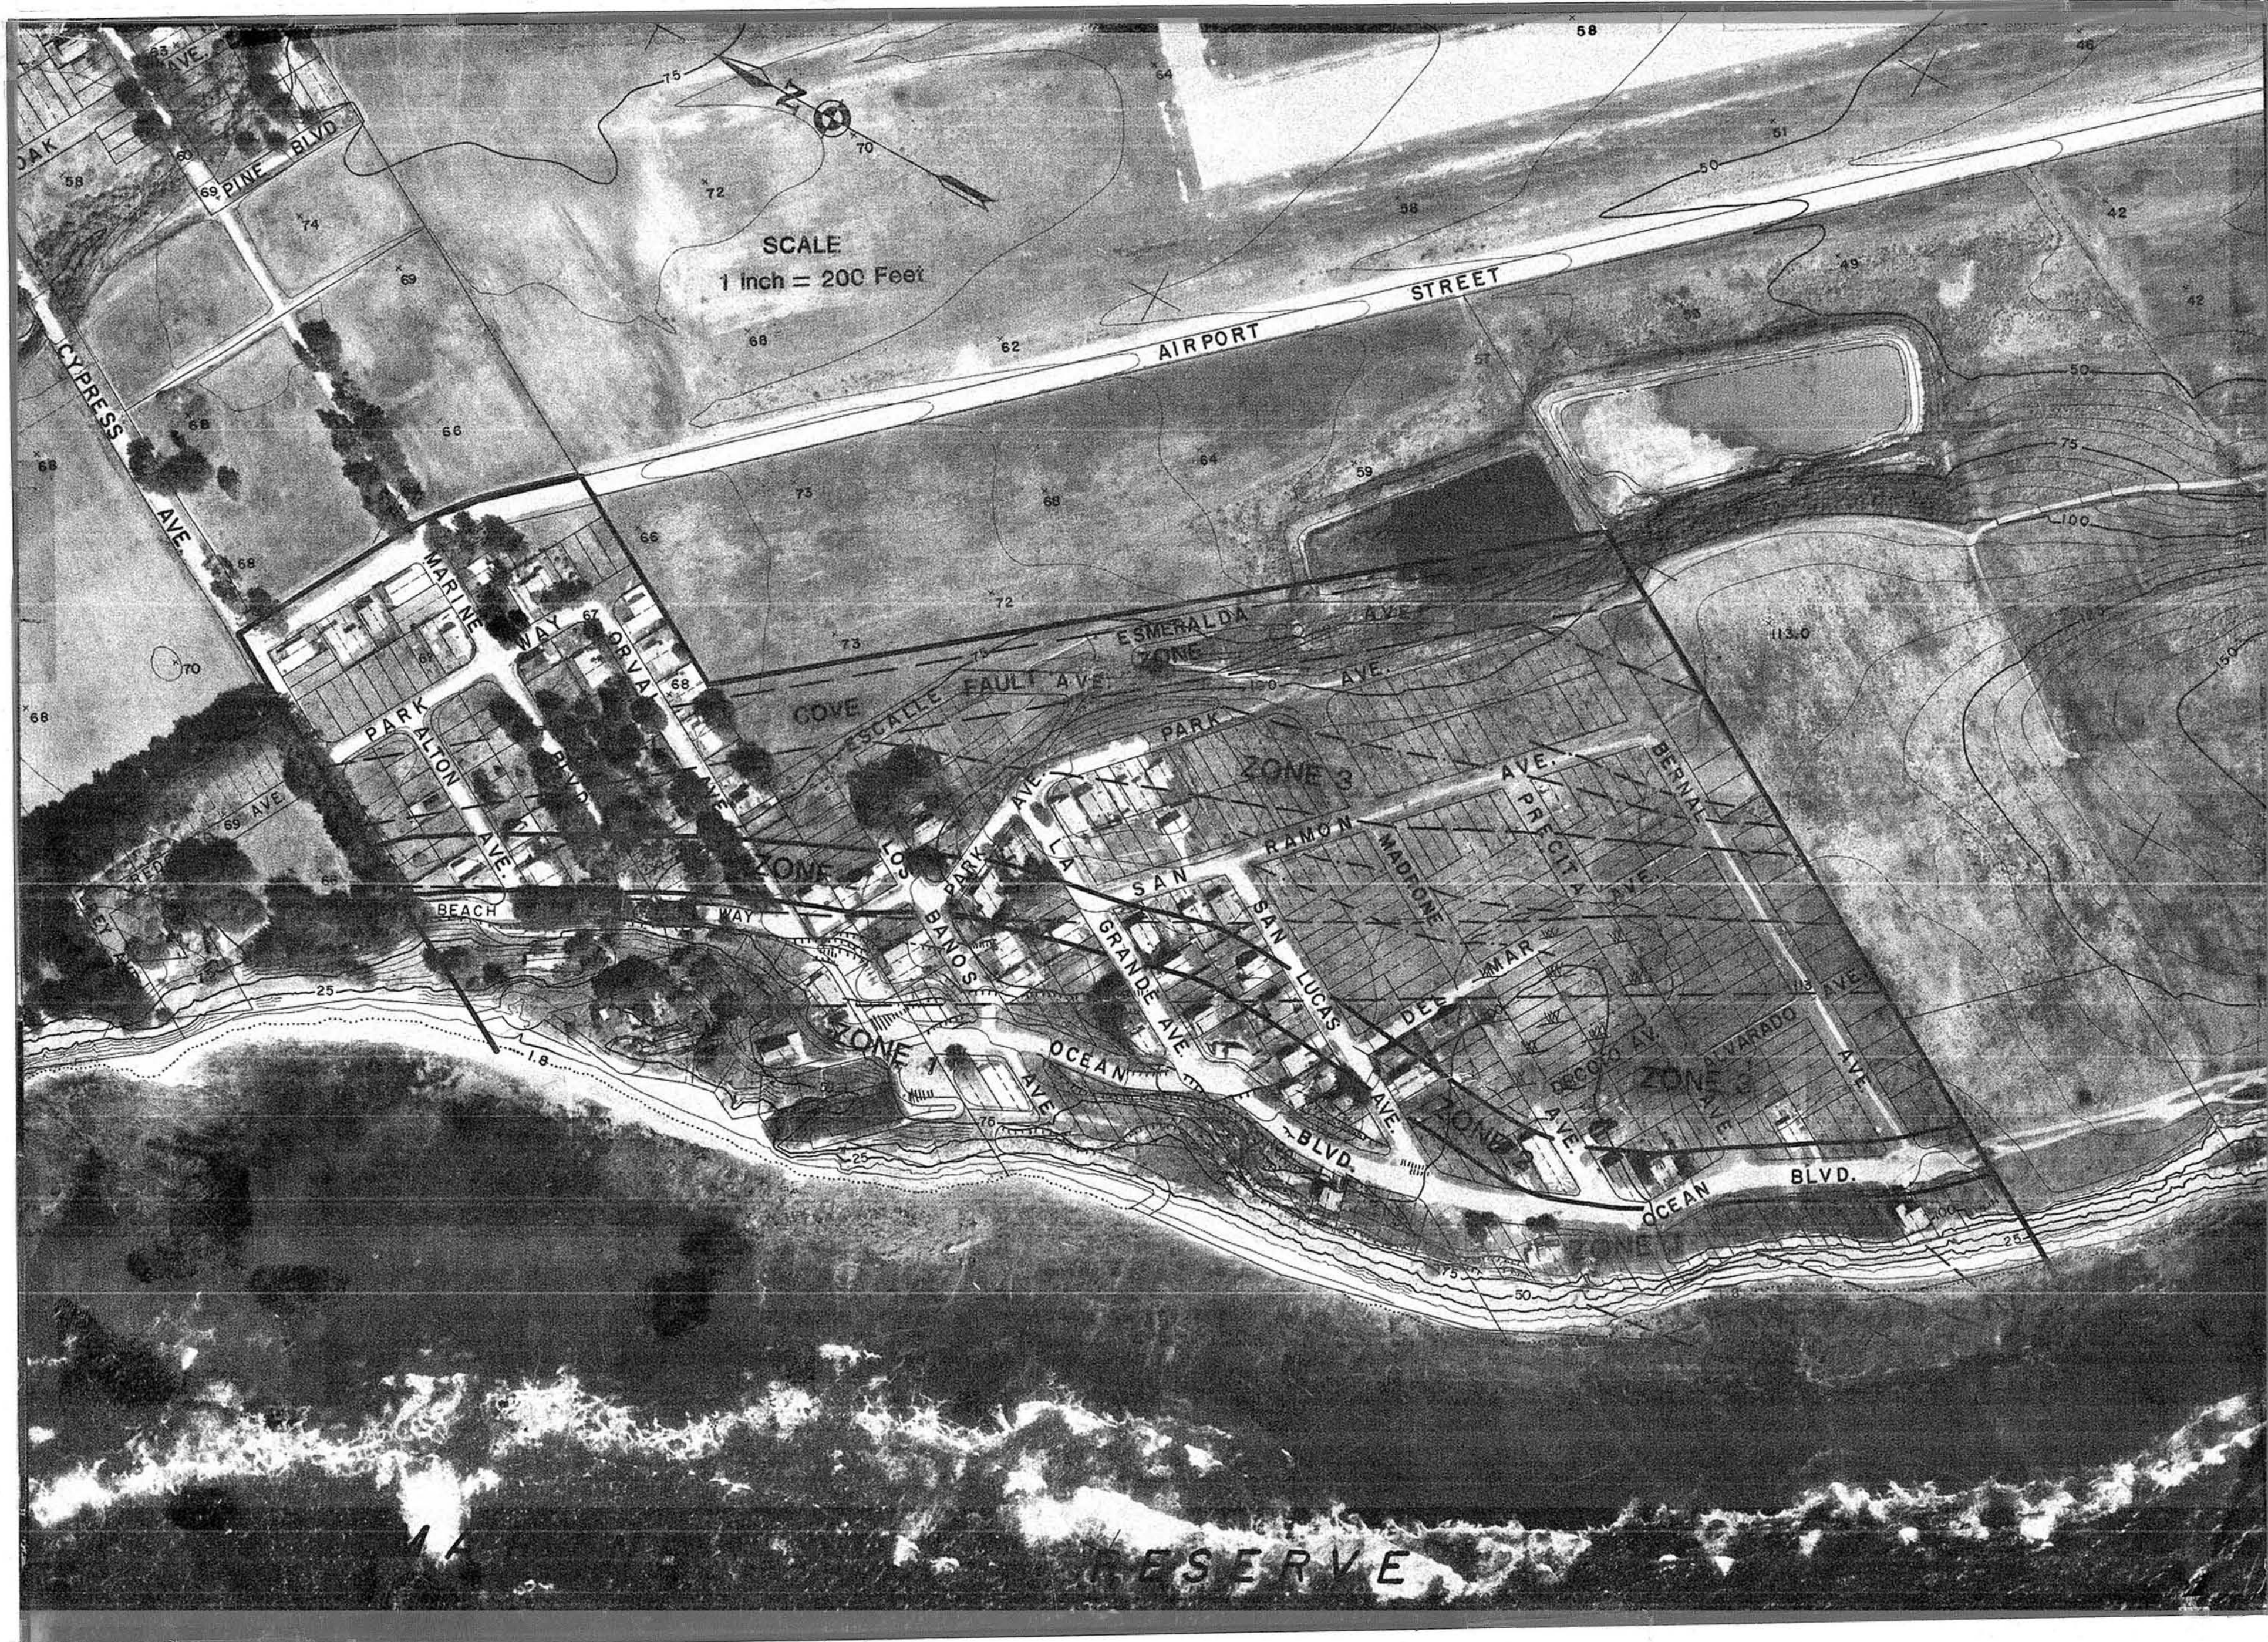
GEOTECHNICAL HAZARD ZONE	RISK ASSESSMENT	REQUIRED GEOTECHNICAL INVESTIGATION
ZONE 1 ■ Includes all lands located along the western seaciff that are adversely affected by active landslide processes and accelerated seaciff erosion. The position of the eastern boundary of this zone is established by the easternmost extent of active landsliding plus a setback of 50 feet. The setback zone includes lands which lie outside or east of the active landslides but are expected to experience problems in the future (i.e. 502 years).	UNSTABLE ■ Risk to development in this zone is considered to be extremely high. It is reasonable to conclude that slow progressive landsliding and seaciff retreat will continue, resulting in structural and property damage. This is especially true for structures or utilities located astride active surface breaks. Rapid catastrophic slope failure of the high, steep portion of the seaciff located west of Ocean Boulevard is a clear probability. Such an event could involve the loss of life as well as significant property damage. The feasibility of reducing the risk to acceptable levels is extremely low. ★ No additional development should be allowed in this zone.	■ No investigation deemed feasible due to the severity of the instability.

ZONE 2 ■ Includes all lands within a 100-foot wide zone located immediately adjacent to the zone of active landsliding and accelerated seaciff erosion (i.e. Zone 1). The position of the eastern boundary of this zone is established in part by an approximate 2:1 (i.e. 261 degrees) projection measured from the base of the high seaciff located west of Ocean Boulevard.	QUESTIONABLE STABILITY ■ Risk to development in this zone is considered to be moderate to high. Eastward progression of active landsliding is difficult to predict with reliable accuracy. The likelihood of eliminating the risk is very low, however it may be possible to significantly reduce the impact of the hazard by properly designed foundations. ★ No development should be allowed in this zone until stability is clearly demonstrated by the required geotechnical investigations.	■ Engineering geologic investigation by a certified engineering geologist and a soil and foundation engineering investigation by a registered civil engineer, or a combined equivalent of the above. • Scope of both investigations should be directed toward a detailed evaluation of the potential landslide hazards in this zone. In most cases, landslide studies will require extensive subsurface work in order to provide the necessary technical data to conduct a detailed slope stability analysis. The geotechnical analysis should provide acceptable factors of safety to clearly demonstrate stability before construction is allowed in this zone.

ZONE 3 ■ Includes all lands located outside of the areas affected by active or potential landslides.	MOST STABLE ■ Risk to development in this zone is considered to be low to moderate. The major geologic hazard in this zone is the threat of surface faulting along the master fault trace and several branching fault traces of the Seal Cove fault. These faults are active and capable of producing damaging surface faulting, strong ground shaking and ground failure. The relative risk associated with poor surface drainage and potentially expansive soils is generally regarded as moderate to locally high. The feasibility of reducing the risks to acceptable levels in this zone is considered high. This can be accomplished by careful siting of homes away from active faults, using careful structural and foundation design and adequate surface drainage plans. However, it is possible that some residential parcels will be judged unbuildable due to high seismic hazards. ★ Development should be allowed in this zone on parcels found to be free of hazardous conditions by the required geotechnical investigations.	■ Engineering geologic investigation by a certified engineering geologist and a soil and foundation engineering investigation by a registered civil engineer, or a combined equivalent of the above, unless evidence is available to show that such investigations are not required. • Scope of engineering geologic investigation should address the seismic hazards related to the master and branching traces of the Seal Cove fault. Particular emphasis of the engineering geologic investigations should be placed on the evaluation of possible surface faulting. Investigative techniques within this area will require the use of subsurface trenching and possibly geophysical traverses unless clear evidence is established to show that no active fault crosses the parcel in question. • The soil and foundation engineering investigation should address, but not necessarily be confined to, the following items: site preparation and grading, surface drainage, and design parameters for residential foundations.

No additional development should be allowed in this zone.

No development should be allowed in this zone until stability is clearly demonstrated by the required geotechnical investigations.

Development should be allowed in this zone on parcels found to be free of hazardous conditions by the required geotechnical investigations.

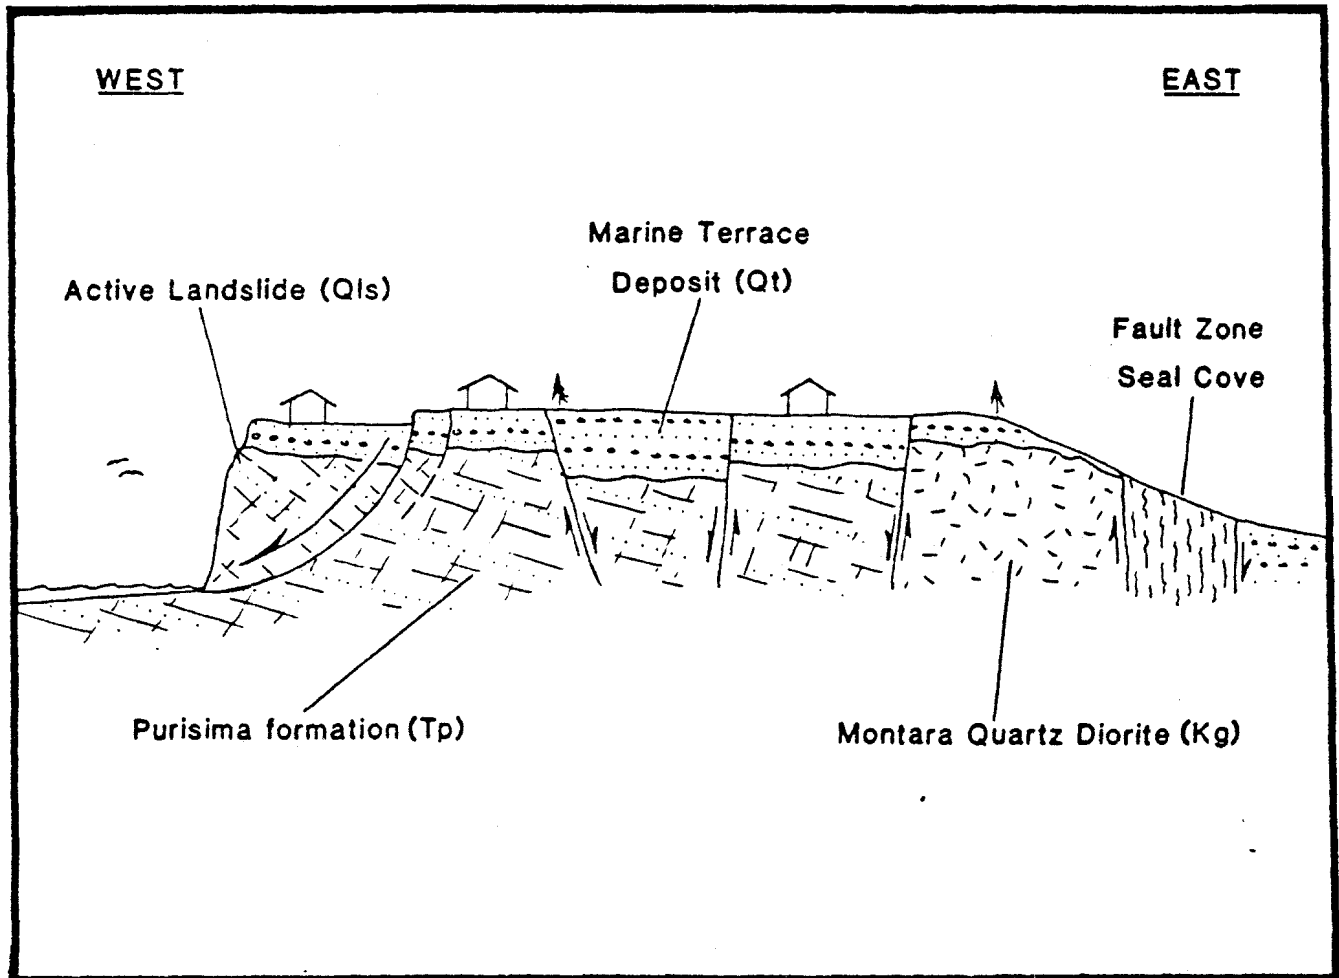
FIGURE 3 SCHEMATIC GEOLOGIC CROSS SECTION

Landslide (Qls) - The landslide deposits are composed of both the overlying surficial Marine Terrace and the Purisima bedrock materials. The primary type of failure appears to be rock slump with movement concentrated along deep-seated failure planes. The landslides are concentrated in a coastal belt along the western margin of the study area that extends inland as far as 300 to 400 feet.

Purisima formation (Tp) - This unit consists of a thin-bedded, highly fractured, inter-layered sequence of siltstone, shale, and sandstone. The bedrock is exposed along the entire length of the seacliff area and has been encountered in drill holes located approximately 800 feet east of the seacliff area.

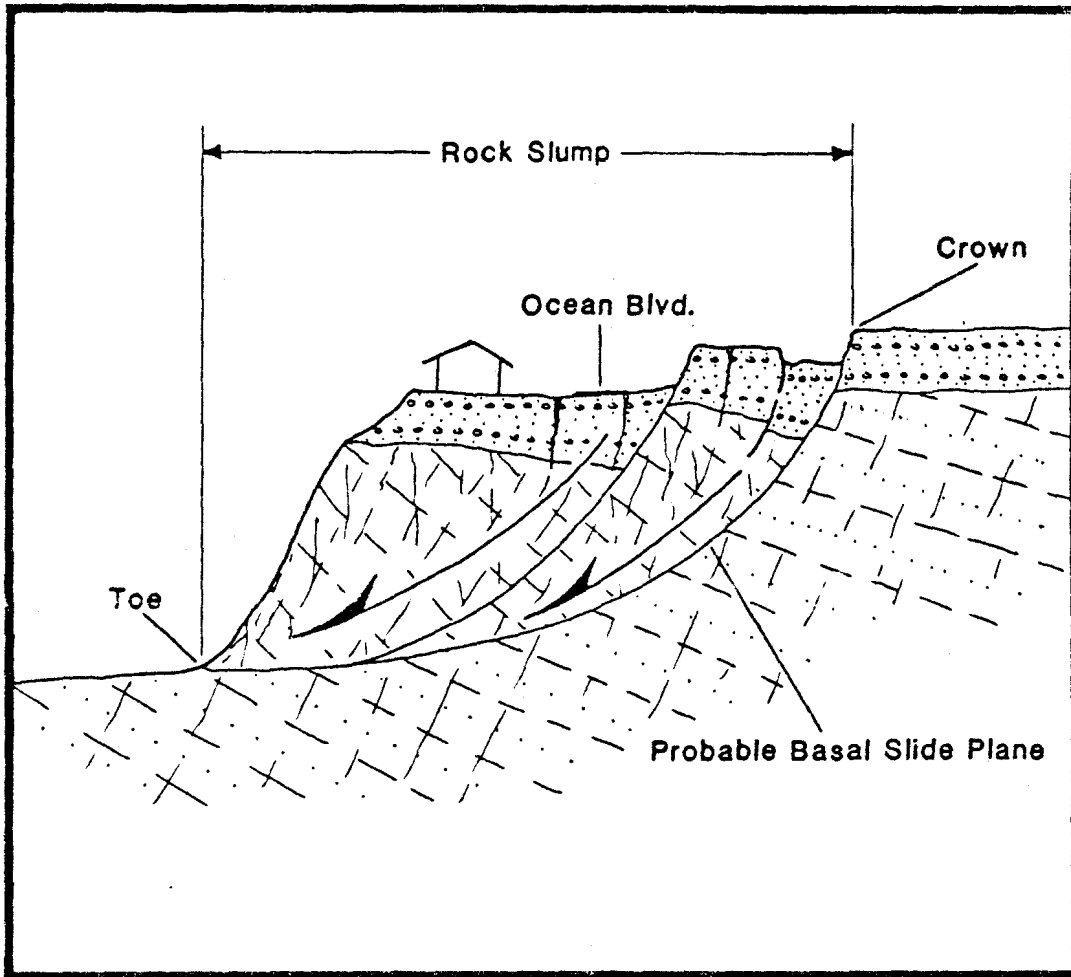
FIGURE 4 MODE OF ROCK SUMP FAILURE
SCHEMATIC CROSS SECTION

Detailed surface mapping and subsurface drill hole data strongly suggest that the mode or style of slope failure can be characterized as (1) progressing from the north to the south and (2) undergoing rotational failure along a concave-upward basal rupture surface. The north-to-south progressive failure is revealed by the pattern and dimension of the surface breaks noted along the crowns of the individual landslides (Figure 5). For example, the eastern limits of the landslides are commonly defined by one or more landslide-related geomorphic features including prominent crown scarps, trenches (i.e. grabens), linear depressions and tension cracks. The pattern of failure normally starts with a well-developed headwall scarp near the crown of a major landslide block. The scarps commonly are more prominent and better developed along their northern extensions. Most can be traced to the south along somewhat discontinuous curvilinear paths, but the scarps frequently diminishes in height to the south and eventually are replaced by shallow linear depressions or a series of tension cracks. Consequently, it appears that most of the landslide headwall scarps propagate slowly to the south from their points of initiation, following a scissor-like pattern with greater surface displacements being concentrated along the northern extension of the headwall scarps.

Although the basal rupture surfaces for most of the landslides is not well defined, they appear to be controlled structurally by the orientation and the spacing of the bedrock fractures. The stratification of the bedrock is inclined into the seacliff. Such an orientation usually accounts for increased slope stability, but the highly fractured nature of the bedrock and the presence of a prominent set of west-dipping continuous fractures reduce the strength of the bedrock and controls the mode of failure.

Thus when the relatively incompetent bedrock is exposed in a high, near-vertical seacliff that has been oversteepened by wave erosion, the rock becomes detached along the planar surfaces of the fractures. Consequently the seacliff fails in a type of landslide known as a rock slump (Varnes 1978) which normally involves bedrock materials that fail by rotation along a curved basal rupture surface.

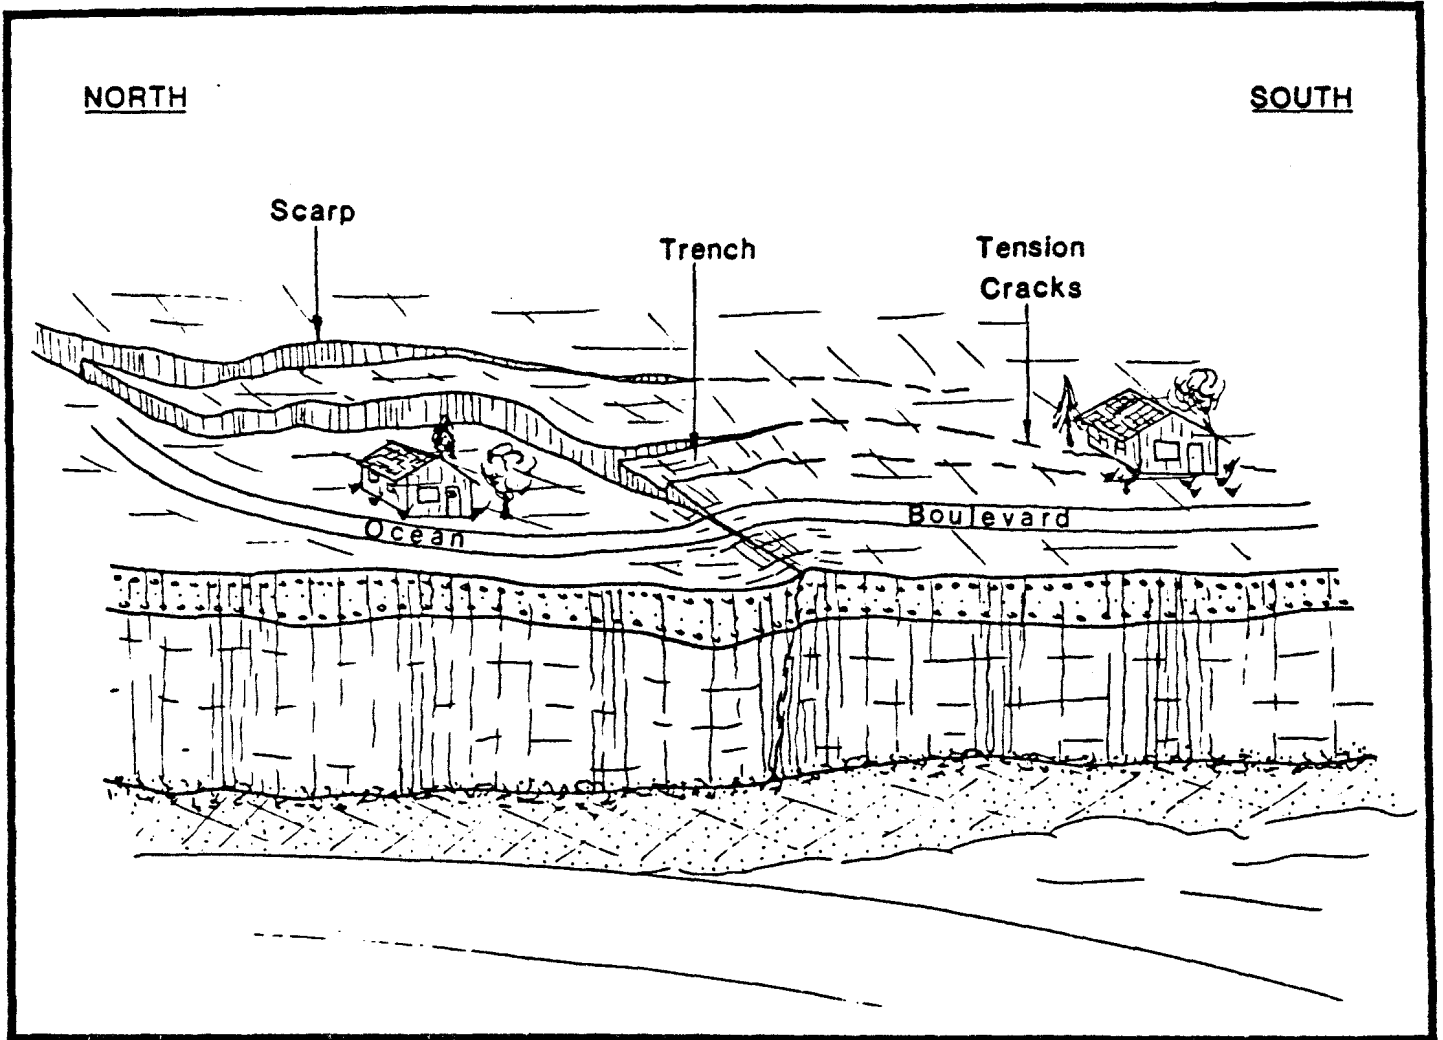
FIGURE 5 PROGRESSIVE NORTH TO SOUTH
FAILURE OF SEA CLIFF REGION

The rate at which these large deep-seated landslide masses are failing can be estimated roughly by noting the increase in the scarp heights and in the length of extensions of the tension cracks since the completion of the original landslide mapping in 1971 (i.e. Leighton and Associates). Our measurements indicate that the rate of failure probably is approximately 1 to 3 inches per year; thus the rate of movement is regarded as very slow. However, the possibility of accelerated movements is considered high in many local areas within the presently failing landslide complex.

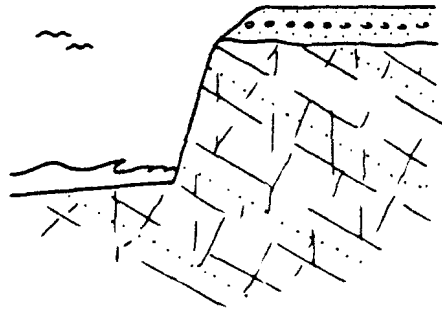
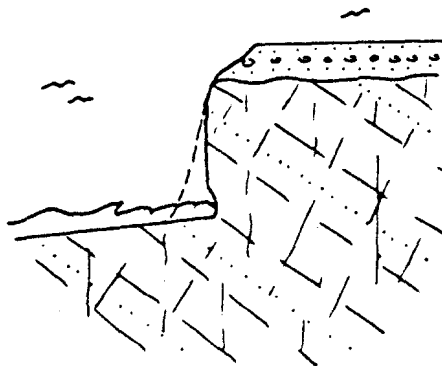
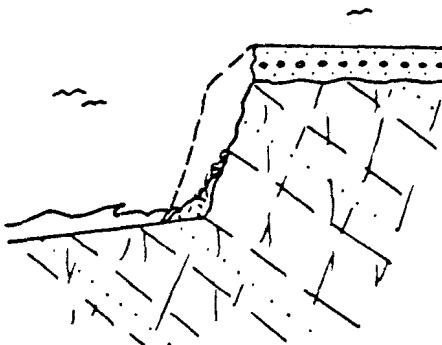
**FIGURE 6 PROGRESSIVE SEACLIFF EROSION
SCHEMATIC DRAWINGS**

SLOUGHING - The most active form of slope failure along the seacliff is shallow, small-scale sloughing and ravelling of the face of the cliff. This process is initiated by wave erosion concentrated along the base of the seacliff (Figure 6). This erosional process causes the base of the seacliff to become undercut and locally unstable. The face of the seacliff responds to the oversteepened condition by localized piecemeal sloughing and ravelling. Most of the cliff retreat takes place during the winter season when storm waves vigorously erode and undercut the base of the seacliff. The weak, highly fractured siltstone and shale bedrock and the unconsolidated cover of marine terrace material are left in an oversteepened and unsupported condition, and consequently fail. The fallen debris temporarily protects the base of the cliff, but the waves eventually remove the debris and the oversteepening process starts anew.

An analysis of aerial and ground photographs taken over a period of fifty years, 1926 to 1976, and map extending back approximately 130 years reveals that the average rate of cliff retreat within the study area is now approximately 3 to 4 feet per year. However, this process is episodic and is controlled by a variety of local geologic conditions, thus the average rate cannot be projected into the future with any degree of certainty. For example, using this rate, it would be unreasonable to predict that the top of the seacliff will be located 30 to 40 feet east of its present location by 1990; there may be only 5 feet of cliff retreat in the next ten years, but 55 feet of retreat may occur the subsequent decade. Thus the average rate over a 20 year period would approximate 3 feet per year.

Stage 1 - Relatively Stable Seacliff

Stage 2 - Local instability due to undercutting of base of seacliff

Stage 3 - Relative stability attained by piecemeal sloughing and raveling

In our judgment, attempts to control or reduce these hazards by engineering design would not be feasible. The scale of the large active landslides make any stabilization scheme essentially uneconomical, likewise an engineering solution needed to stop the erosional activity at the base of the seacliff would severely impact the James V. Fitzgerald Marine Reserve which includes the Seal Cove surface zone. Consequently it appears the most prudent way to reduce the risk is to avoid the areas that are vulnerable to these slope failure hazards.

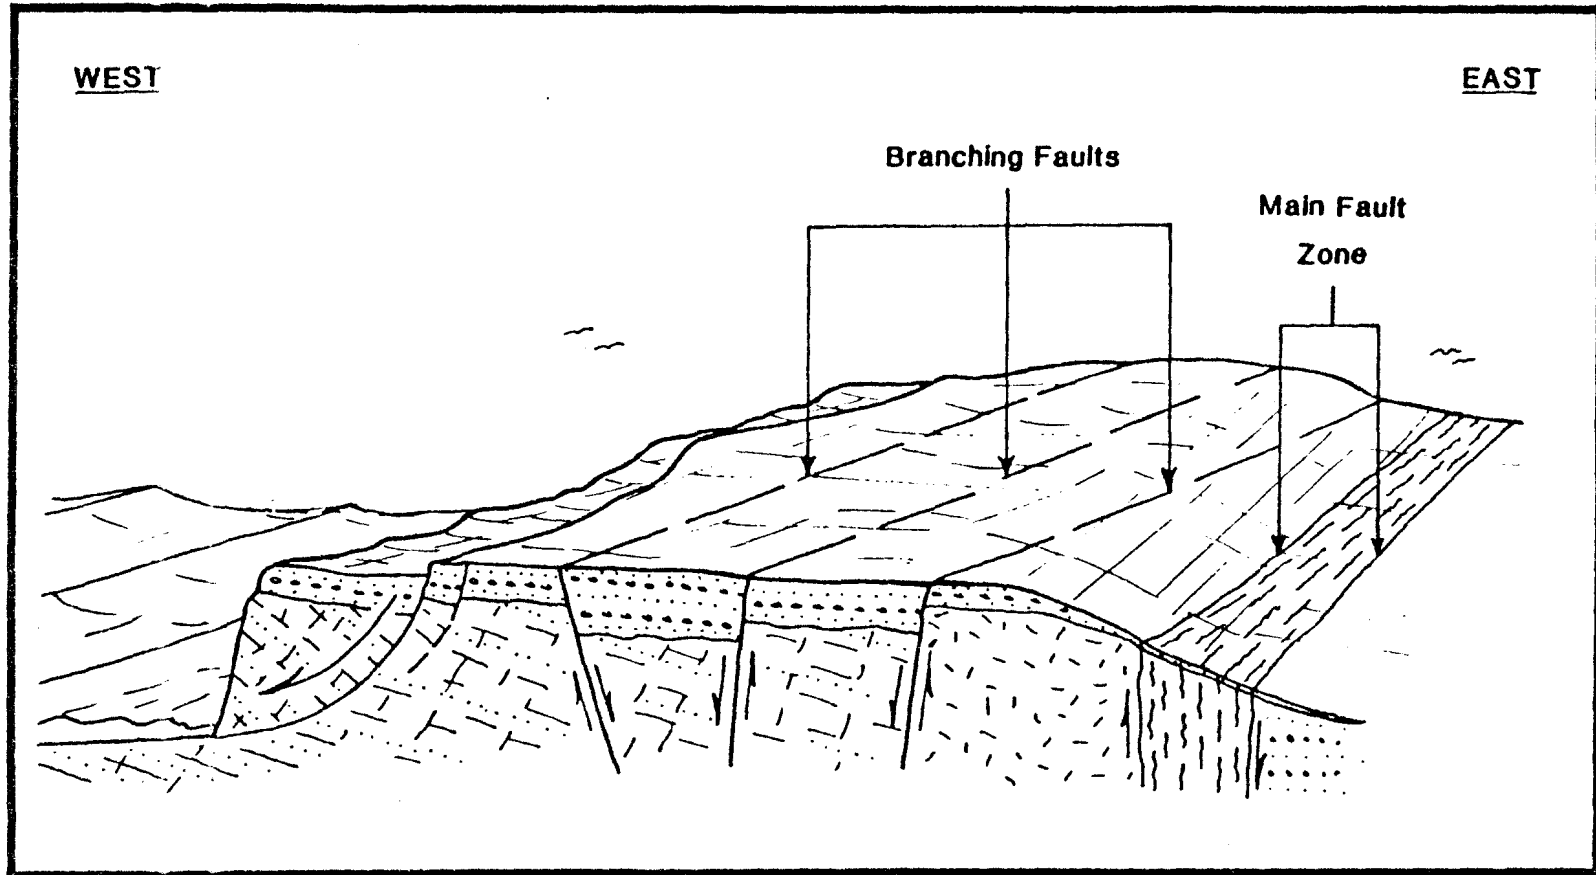
FIGURE 7 SEAL COVE FAULT SYSTEM

These branch faults, like those in the main fault zone are considered to be normal faults characterized primarily by vertical displacements. The main fault trace is identified as the zone of greatest concentration of displacement. Indeed the east-facing slope that forms the eastern boundary of the study area is considered to be a fault scarp produced by displacement along the main trace of the Seal Cove fault. Although the branch faults also are considered to be active traces, both the surface expressions of these faults and the subsurface data presented by the Leighton report indicate that the amount of displacement and the state of activity along these faults probably is much less than the master trace.

In conclusion, the main trace and the branching traces of the Seal Cove fault are considered to be active. The branching faults located in the relatively undeveloped area south of San Lucas Avenue are only approximately located. Indeed, there may be additional fault strands that are as yet unrecognized in this region. Should a major earthquake take place along the Seal Cove fault the anticipated seismic hazards would be severe ground shaking, surface faulting along the master trace and branching fault traces and ground failure (landsliding, sloughing, settlement, etc.). The risk associated with these hazards can be dramatically reduced by carefully siting homes away from active fault traces or potential zones of ground failure and by careful structural and foundation design.
