**COUNTY OF SAN MATEO  
PLANNING AND BUILDING DEPARTMENT**

**SUBJECT:** EXECUTIVE SUMMARY: Consideration of a Coastal Development Permit (CDP) to: 1) allow the “after-the-fact” placement and retention of 24 warning signs to keep the public away from hazardous bluff tops; 2) make repairs to an access ramp leading down from the bluff top; and 3) allow the “after-the-fact” removal of five Monterey cypress trees that were hazardous, at various locations within the Fitzgerald Marine Reserve and the Mirada Surf West County Park, in the unincorporated Moss Beach and El Granada areas of San Mateo County. This project is appealable to the California Coastal Commission.

# TREE RISK ASSESSMENT SUMMARY REPORT

April 2017

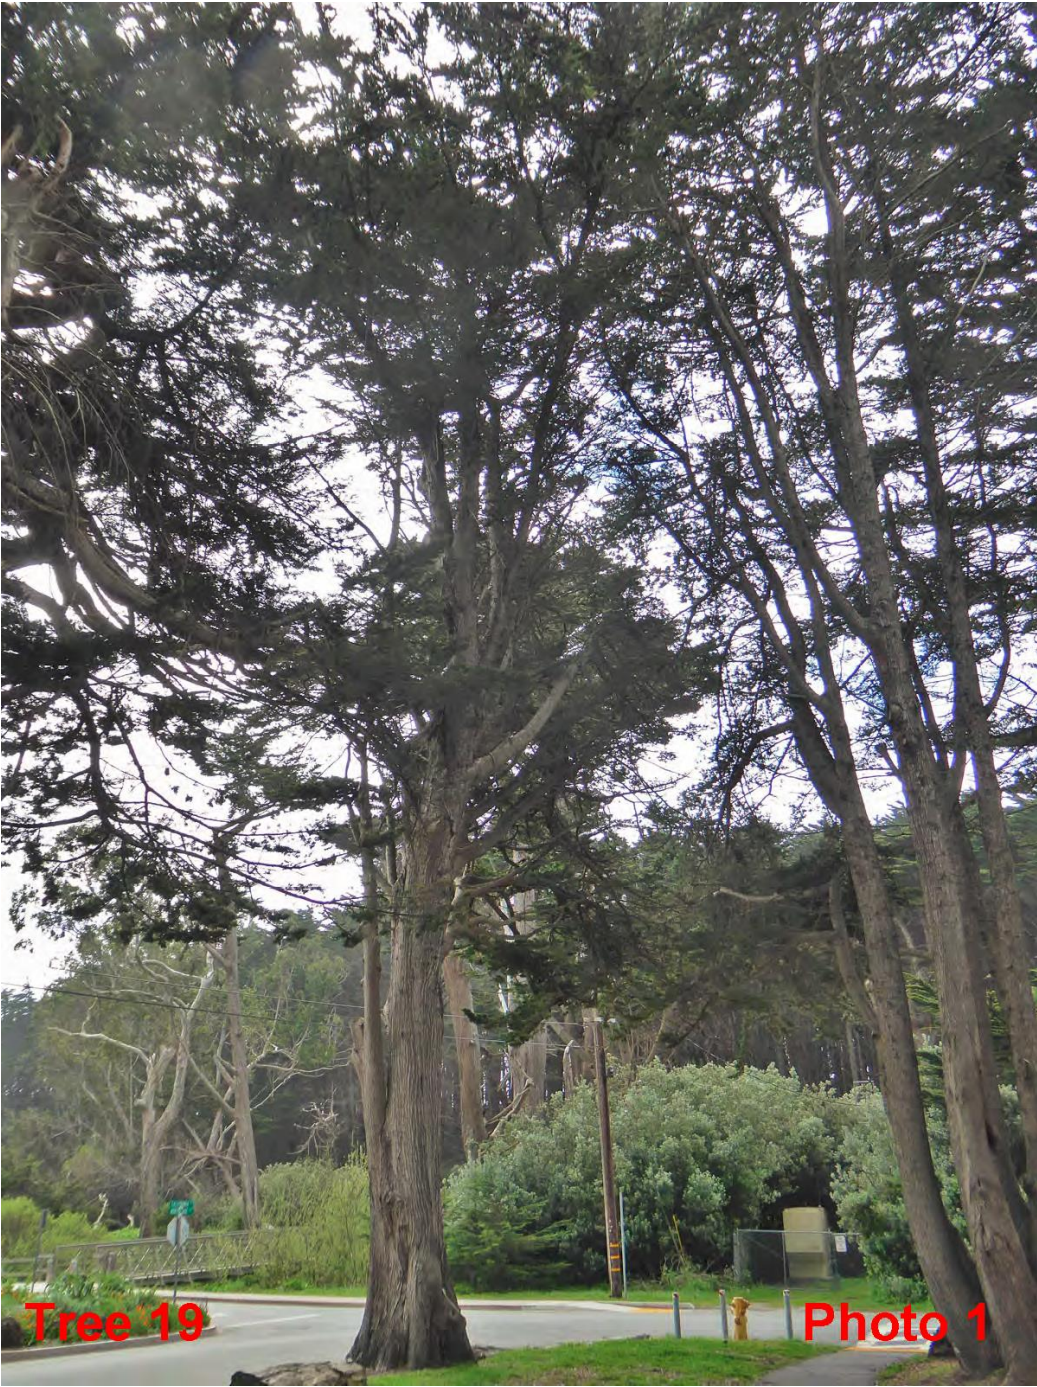
This tree has fungal fruiting bodies within a large cavity. The cavity was probed with a steel tile probe, and the trunk was sounded with a mallet to identify the thinnest areas. Testing sites 1 and 2 for tree 19 are these areas, and site 3 was taken as a calibration point to establish what normal results should look like for this species at this location. Tree 19 Site 1 did not appear to have any decay to the full 11.2-inch depth. Tree 19 Site 2 had solid wood to a depth of 8.5 inches. The root flare and buttresses did not sound hollow when assessed with the mallet, and probing with a tile probe did not detect excessive decay. This tree appeared to be upright, but with a highly asymmetric crown. Because the tree has a thick shell wall without appearance of any propagating cracks, this tree appears to be stable at this time. Given storm conditions, with wind loads acting against the highly asymmetric crown, tree failure is possible.

Photo 1. Tree #19 on SE corner

Removal of this tree is recommended

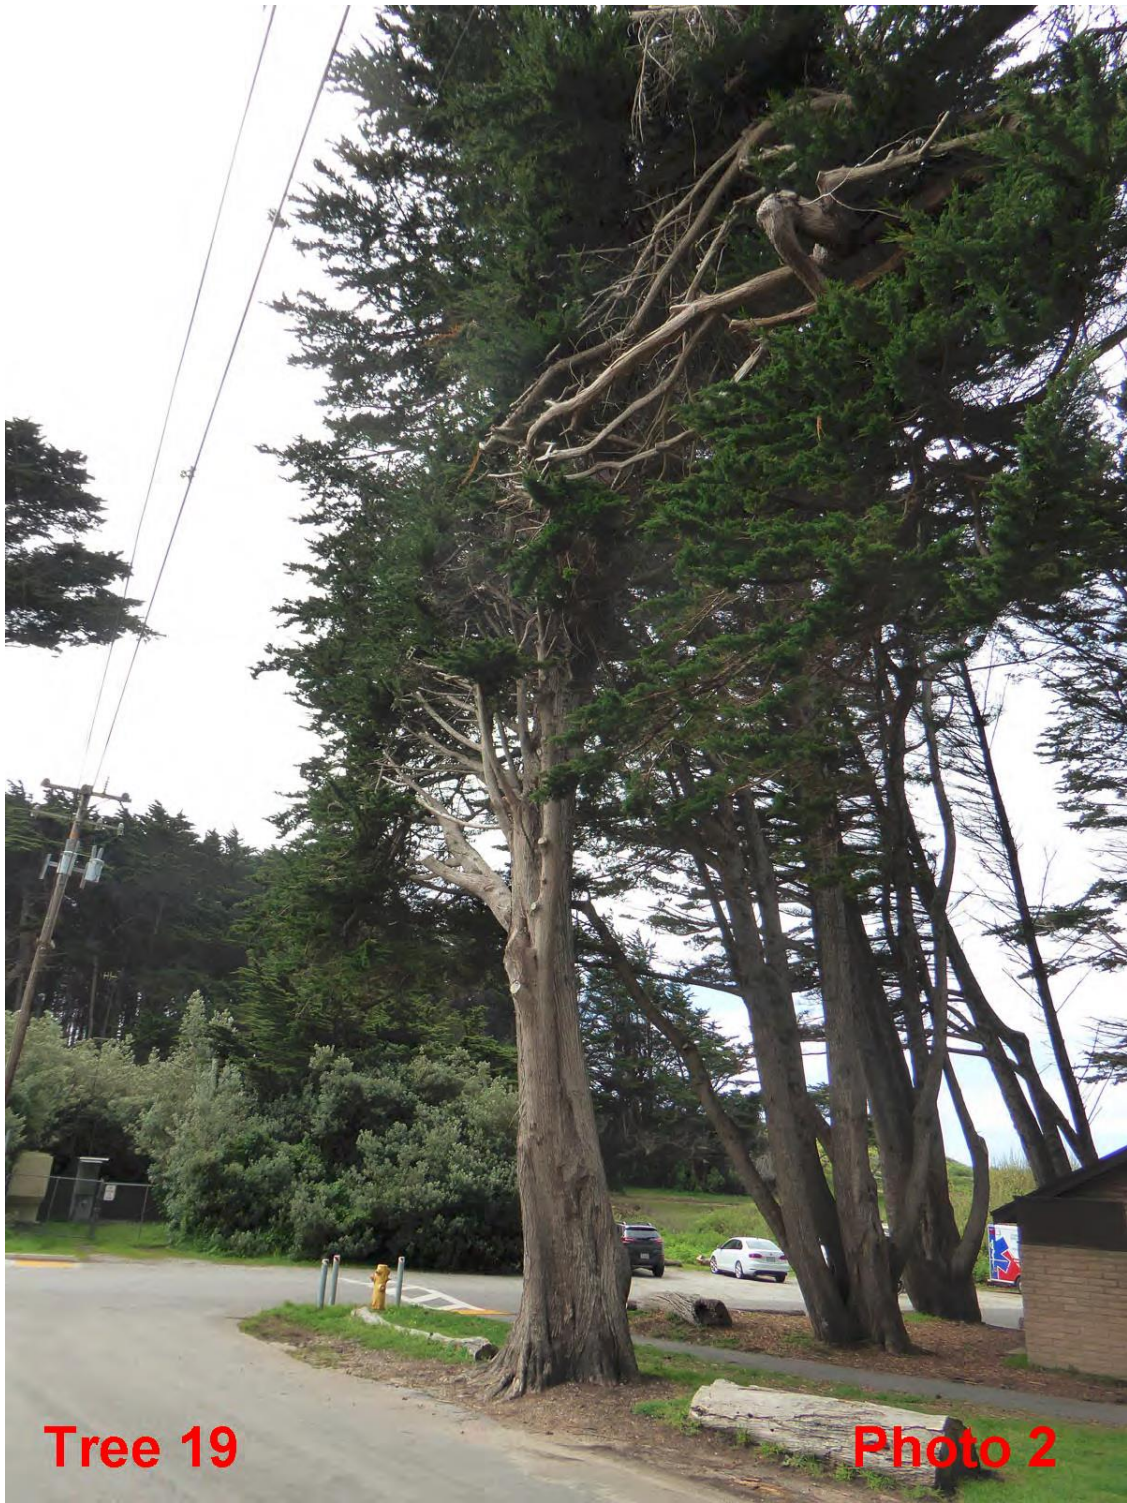
**Photo 2. Tree #19 in close proximity to high voltage wires**

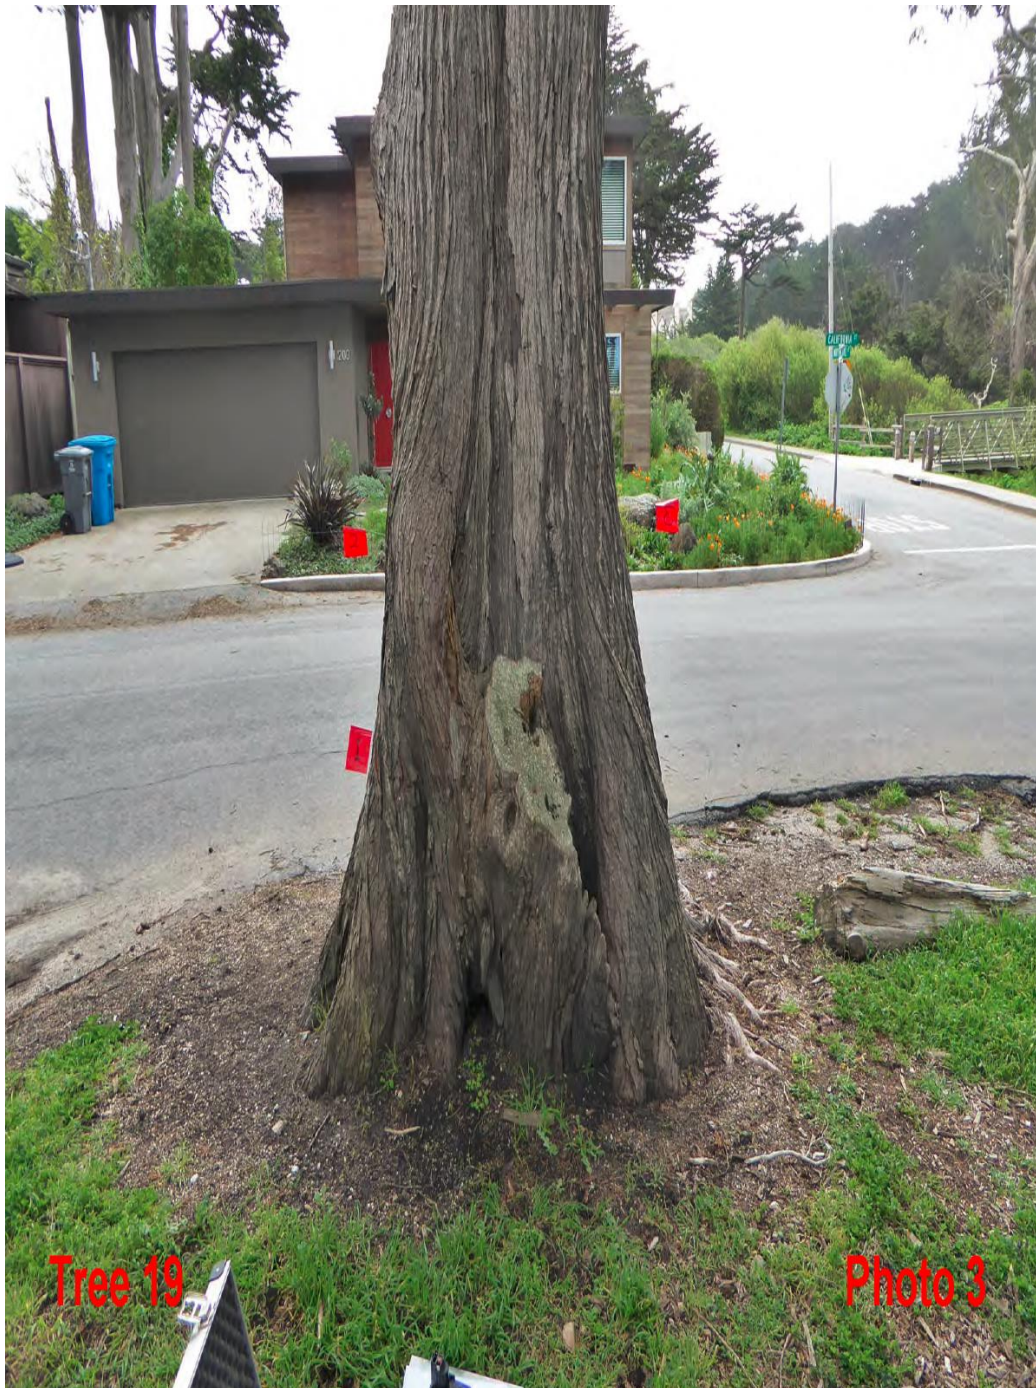
**Photo 3. Resistance drill sites marked with red flags**

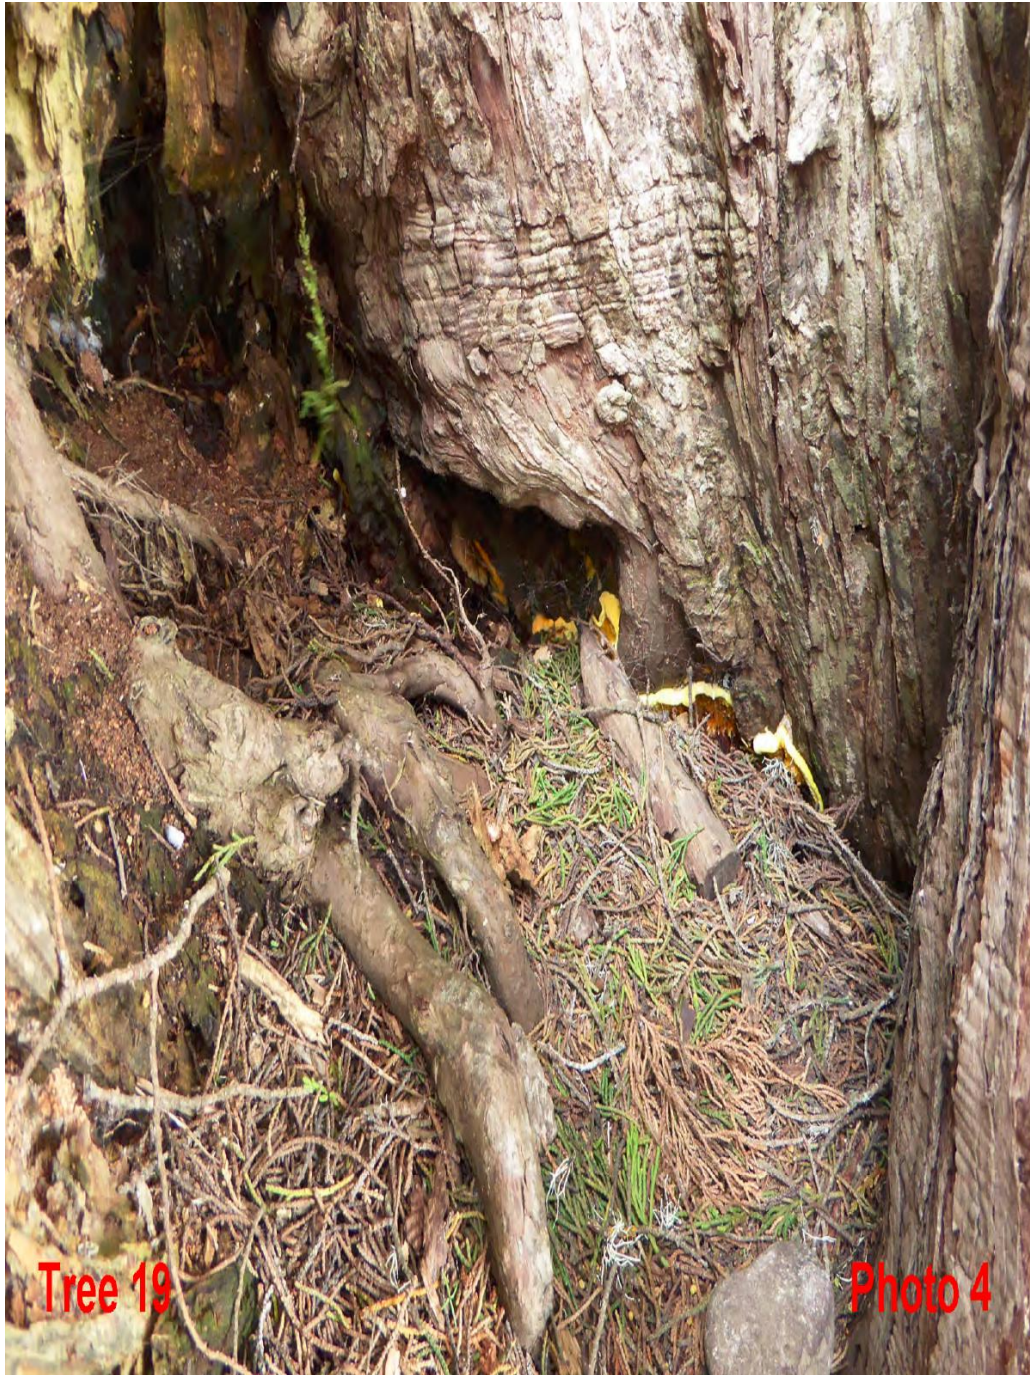
**Photo 4. Trunk cavity & decay in tree #19**

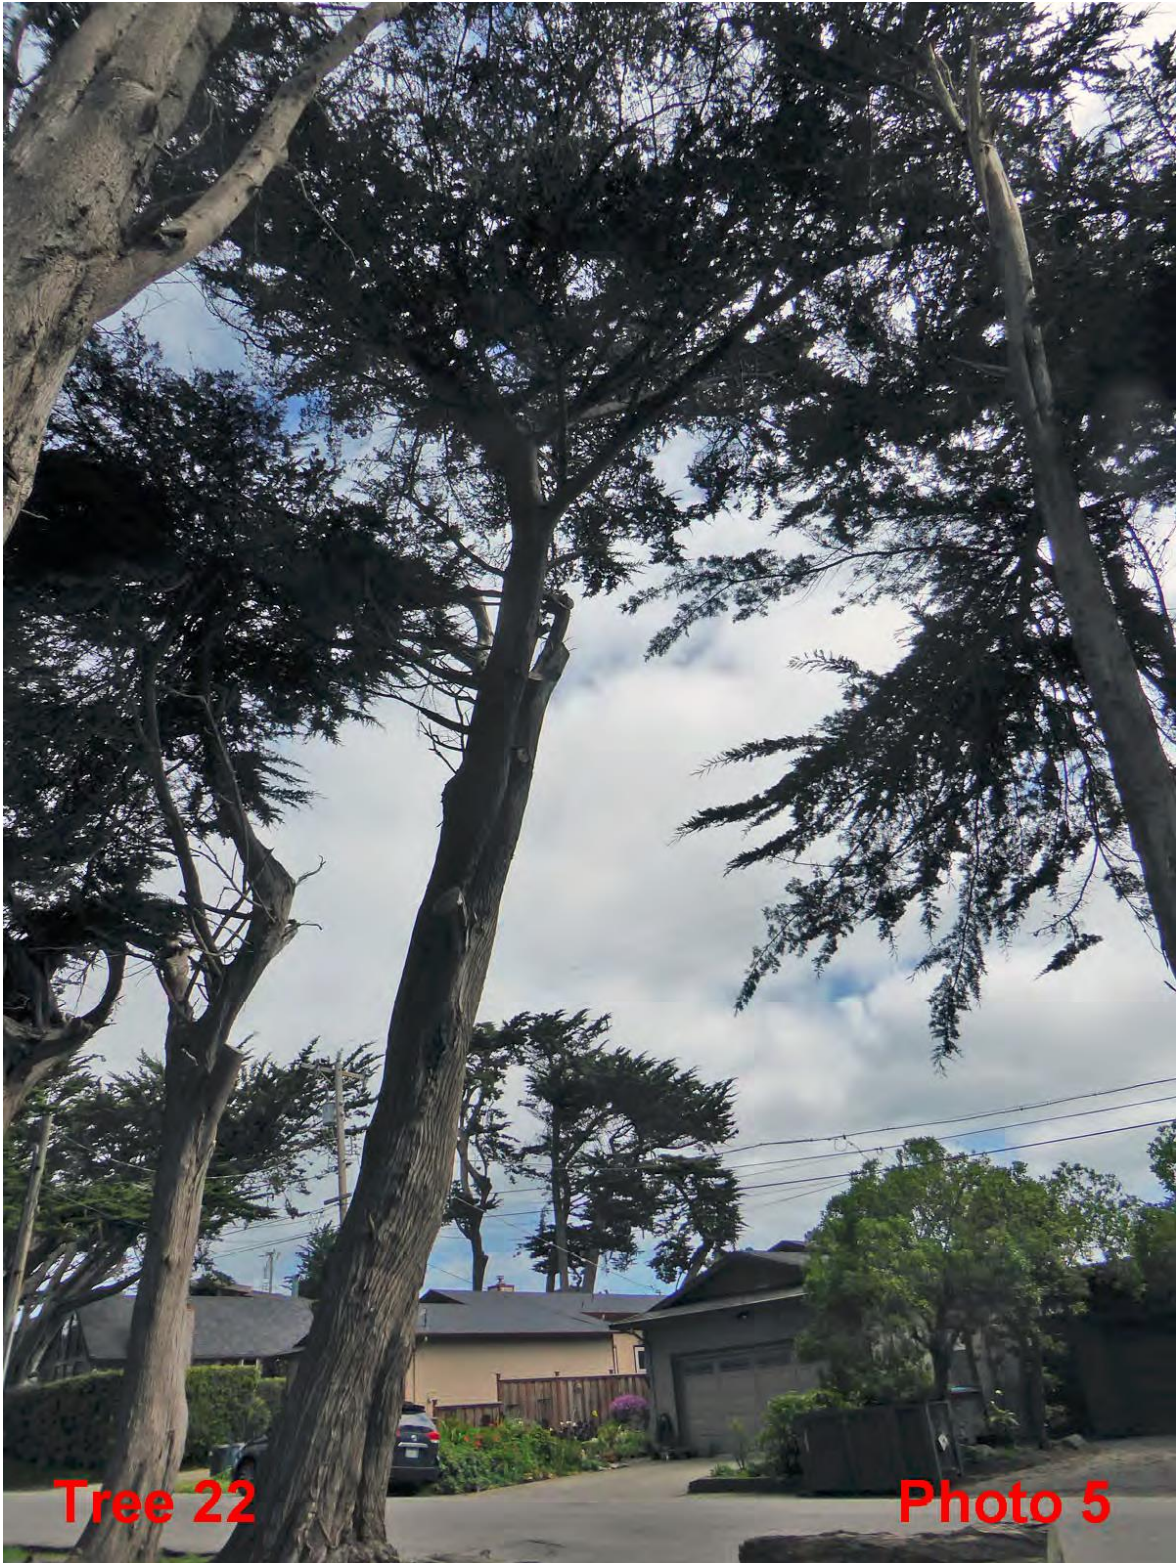
This tree has a large open cavity associated with a scaffold limb removal on the street side of the tree. The trunk has a pronounced lean toward the street, high voltage lines, and houses across the street. No evidence of recent uprooting was found. The lower 8 to 9 feet of the trunk was sounded with a mallet, and no pronounced thin areas were detected. Two resistance drilling sites were chosen at either side of the cavity, and Tree 22 Site 1 had solid wood to beyond 8 inches, and Tree 22 Site 2 had solid wood to the full 11.2-inch depth.

Because of the pronounced lean, this tree will strike the road, high voltage lines, and possibly the house or houses across the road should it fall. Based on the size of the cavity, it is possible that a trunk failure occurs at that point, and it is also possible that the tree would uproot. Given storm conditions, with wind loads acting against the upper part of the tree, uprooting failure is most likely of these two failure scenarios. Because of the size of the part to fail and the constant presence of targets, this tree is given a 'High' hazard rating.

**Photo 5. Tree #22 leaning over street**

Removal of this tree is recommended.

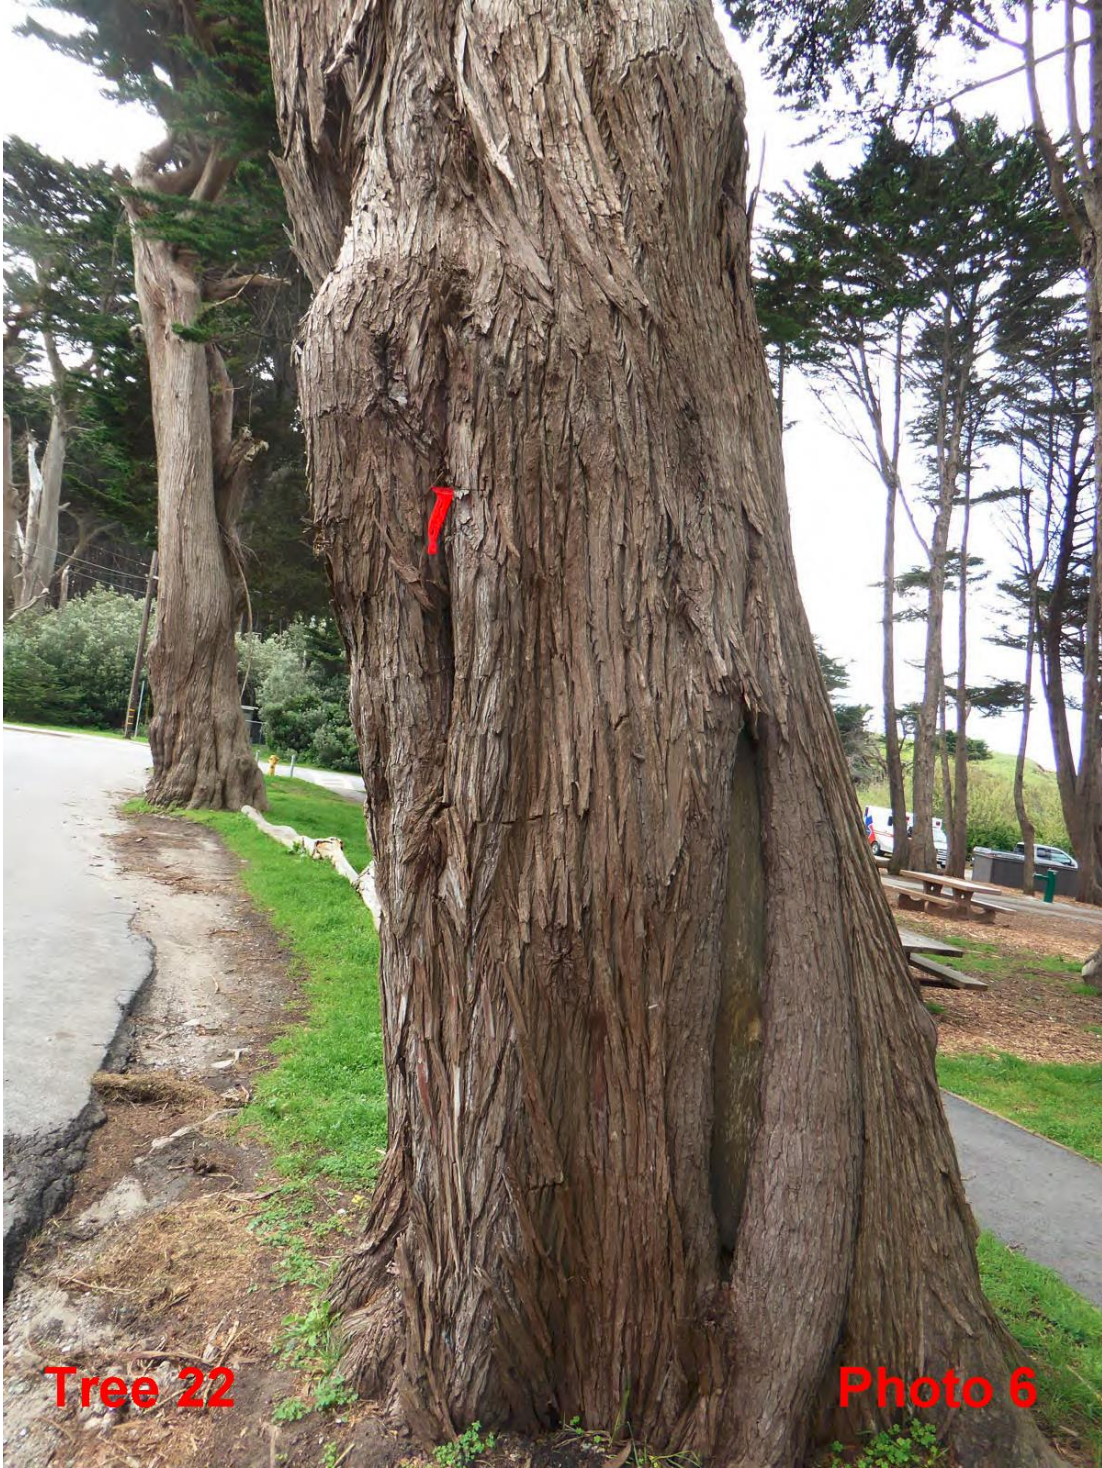
**Photo 6. Resistance drill site in tree #22**

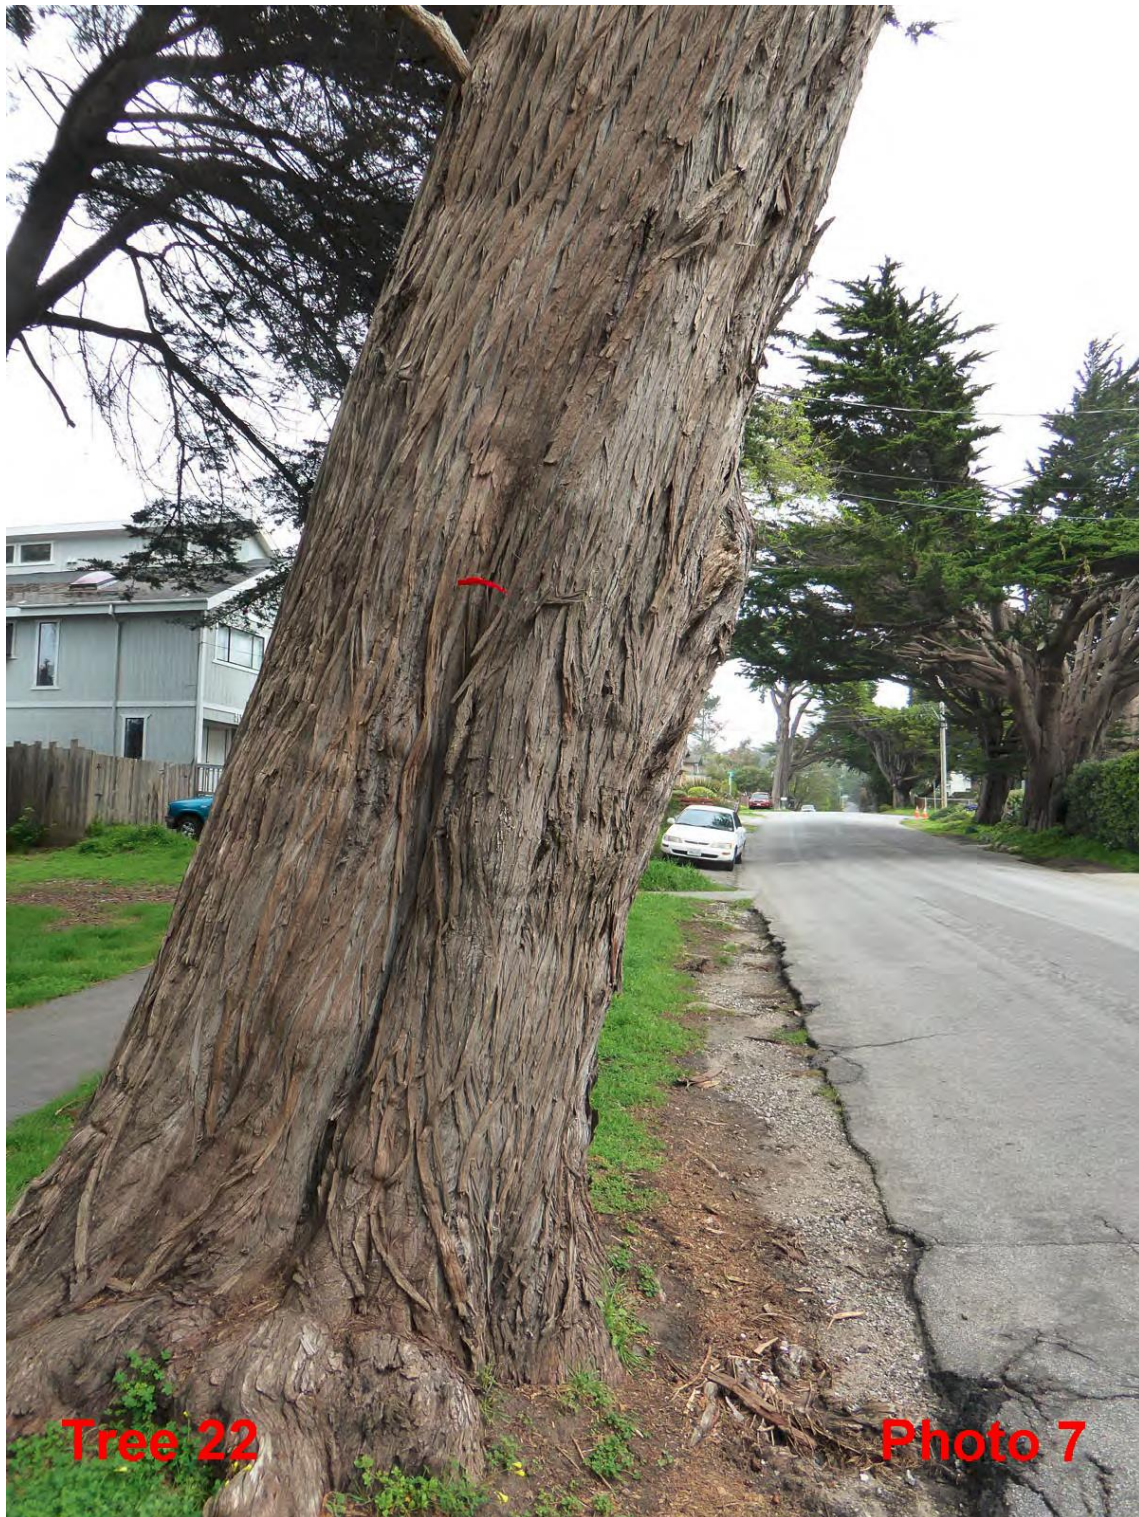
**Photo 7. Second drill site in tree #22**

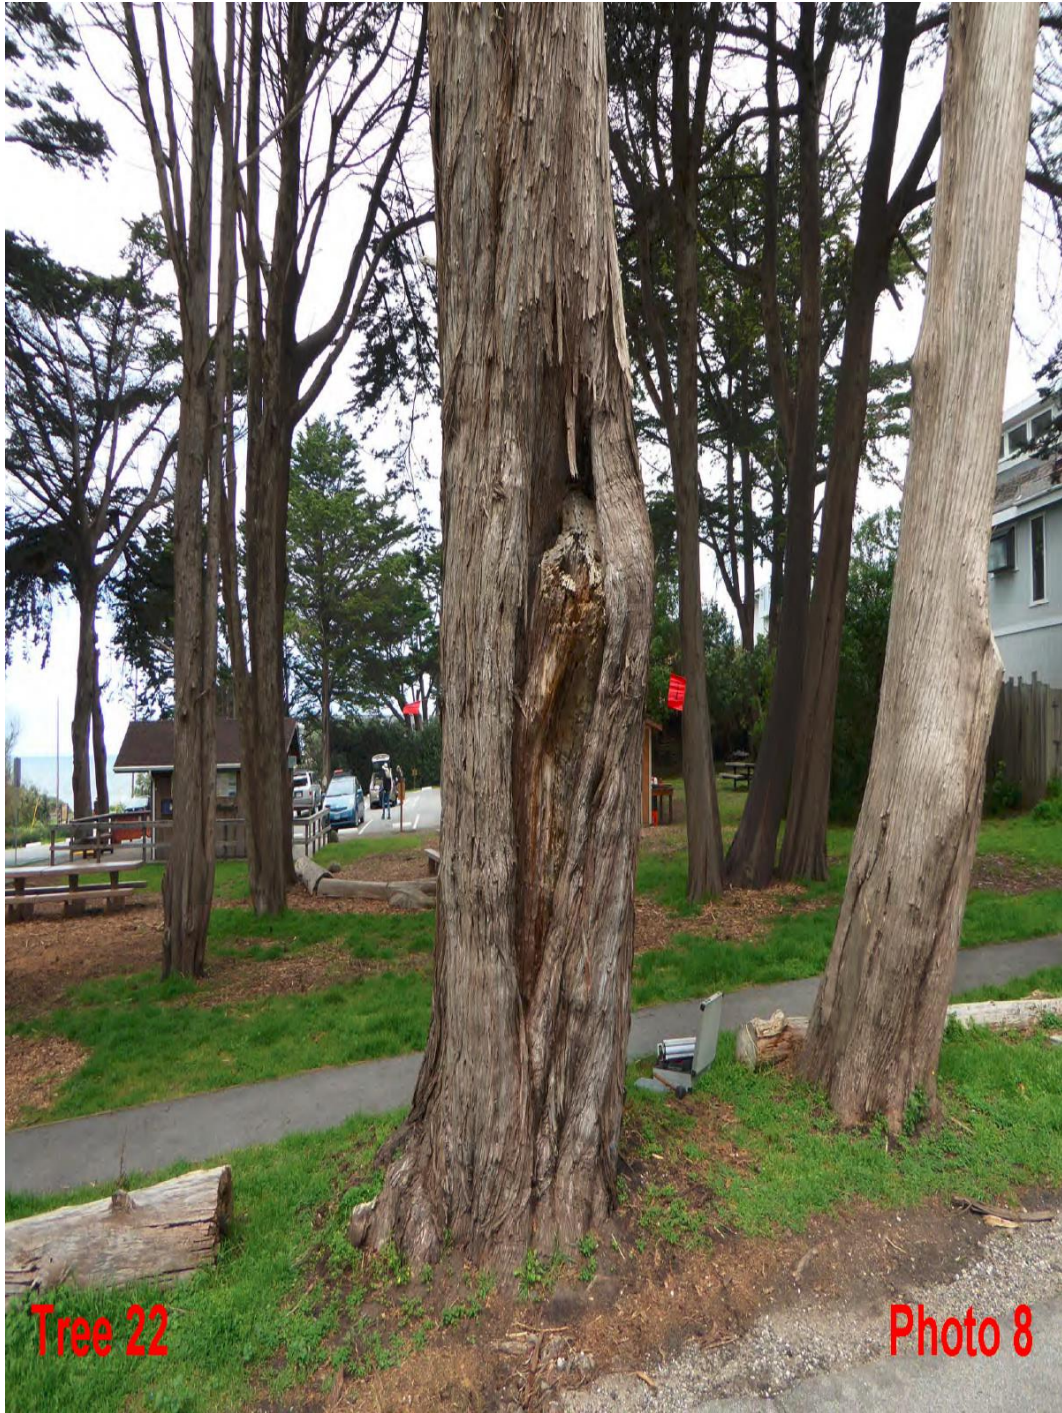
**Photo 8. Trunk decay & drill sites in tree #22**

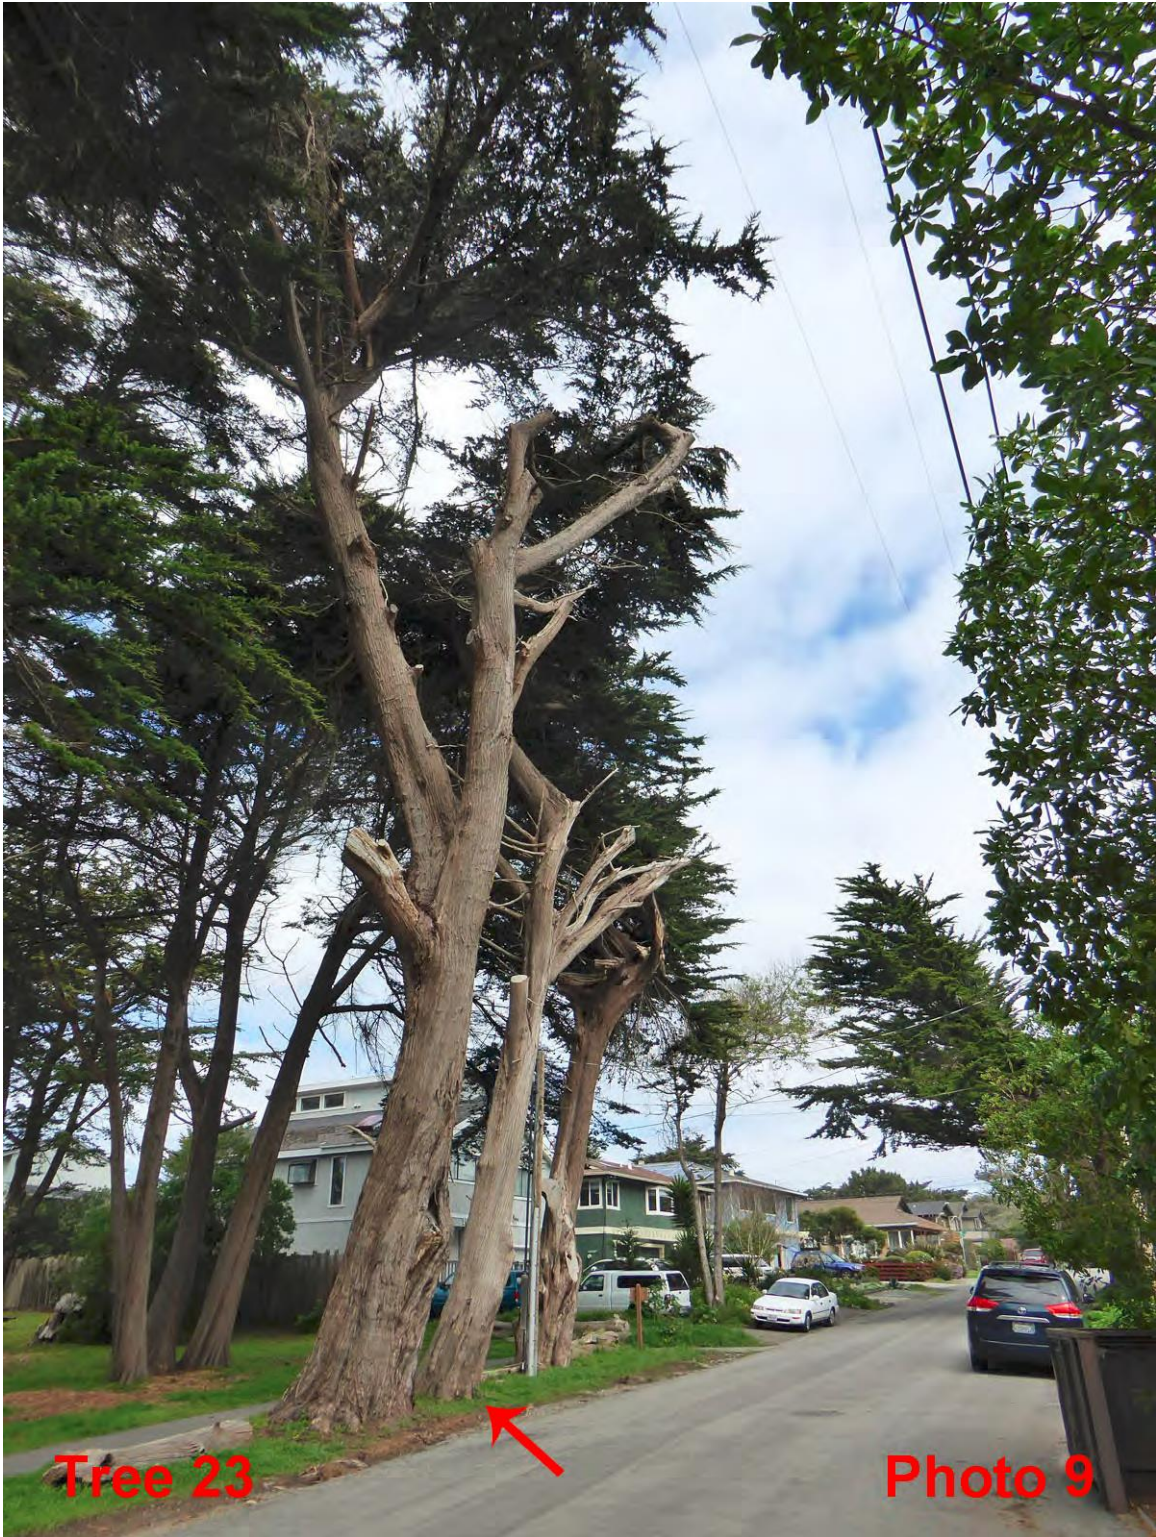
This tree has a large open cavity where a scaffold limb was removed along the street side of the tree. The trunk has a pronounced lean toward the street, high voltage lines, and the houses across the street. Mushrooms were found in the grass on the side opposite the lean, and within about 4 feet of the base of the tree. Sounding with a mallet detected an area that could have been somewhat hollow, but resistance drill testing at that site did not find any evidence of decay. Given the lean of the tree, and the presence of mushrooms near the base of the tree, it is possible that this tree would fall during storm conditions, or possibly without warning on even a calm day. Because of the size of the part to fail, and the constant presence of targets, this tree is given a 'High' hazard rating.

**Photo 9. Crowded location of tree #23**

Removal of this tree is recommended.

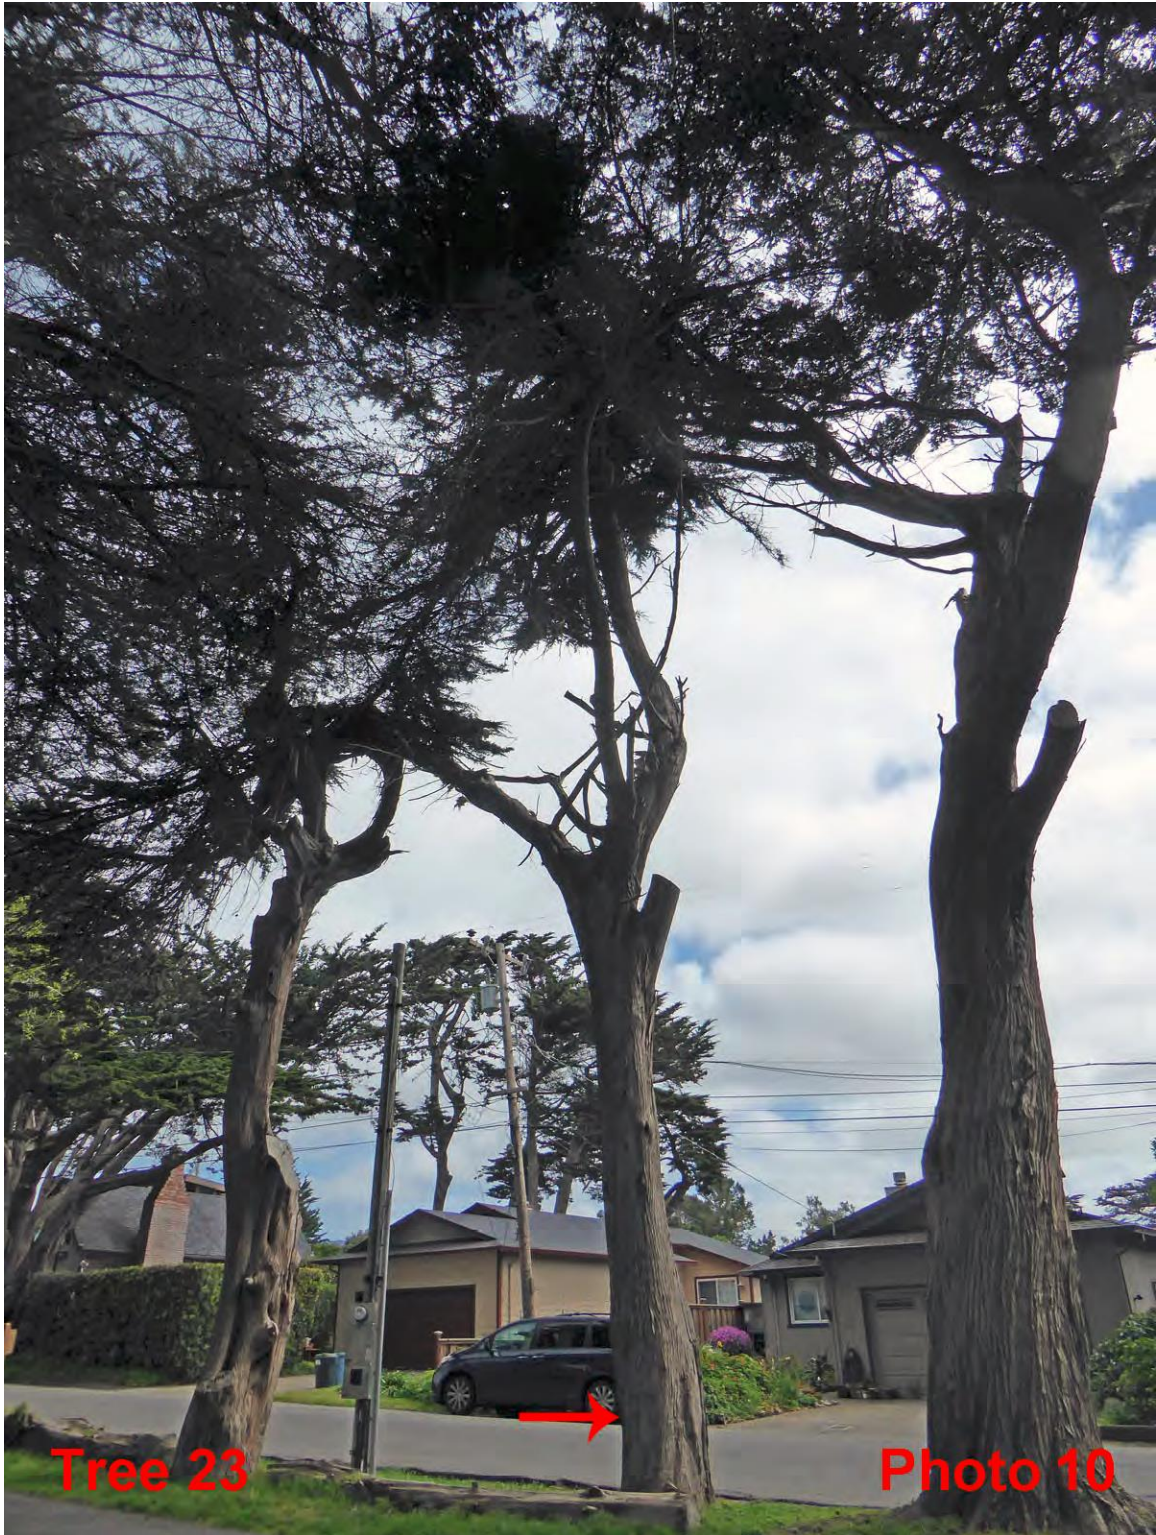
**Photo 10. Utility pruned canopy of tree #23**

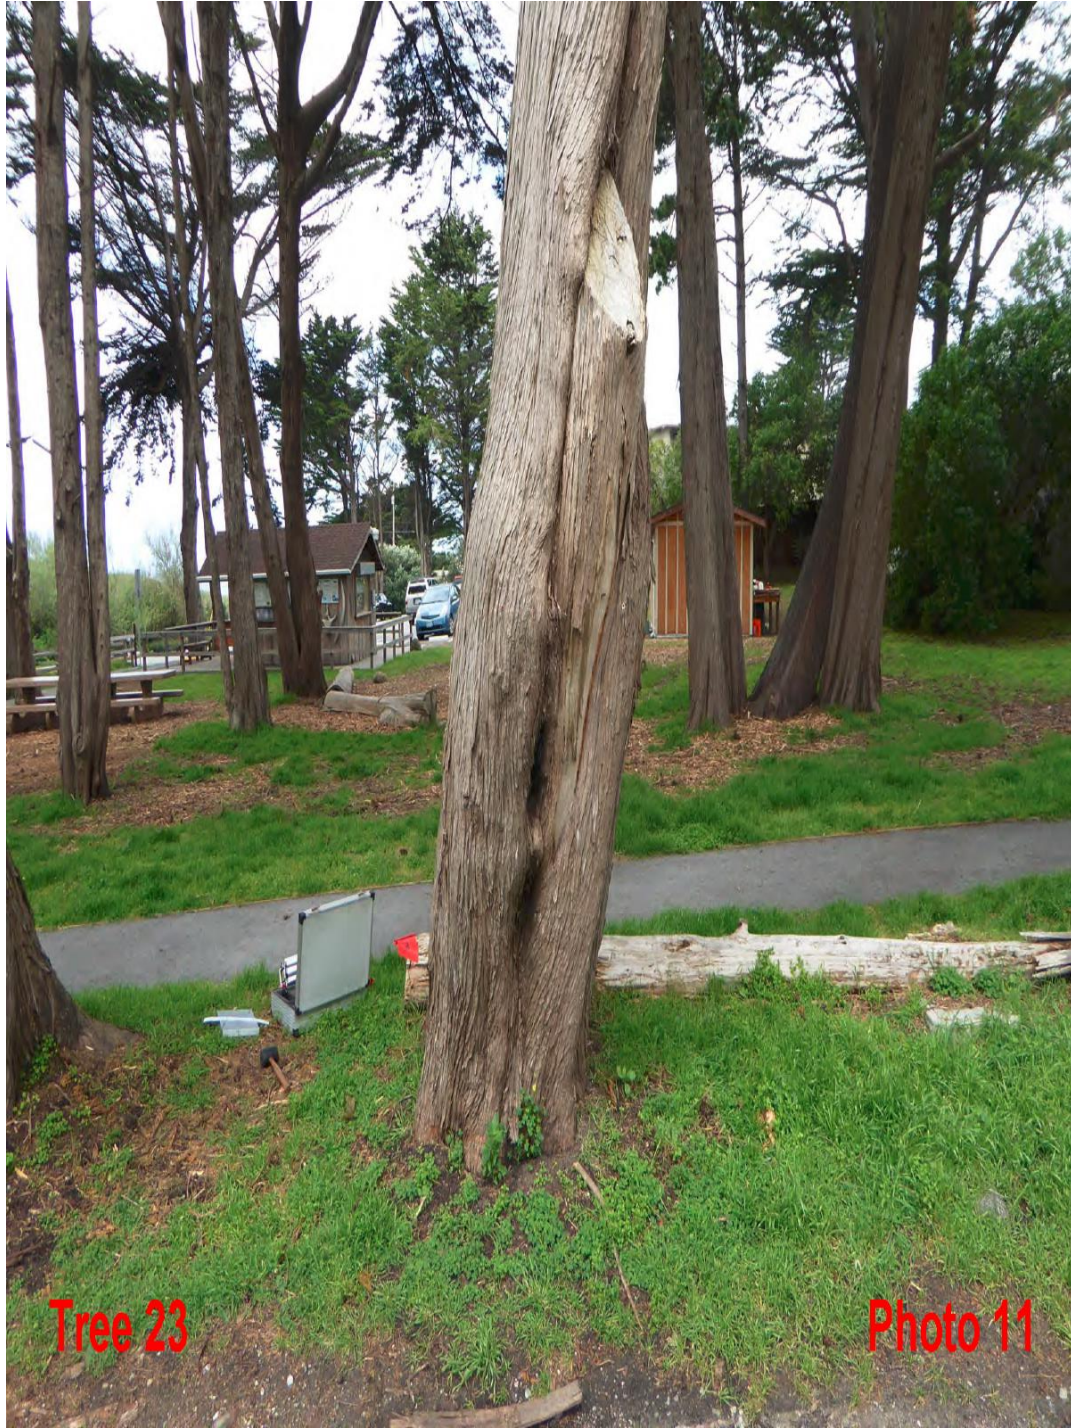
**Photo 11. Drill site in tree #23**

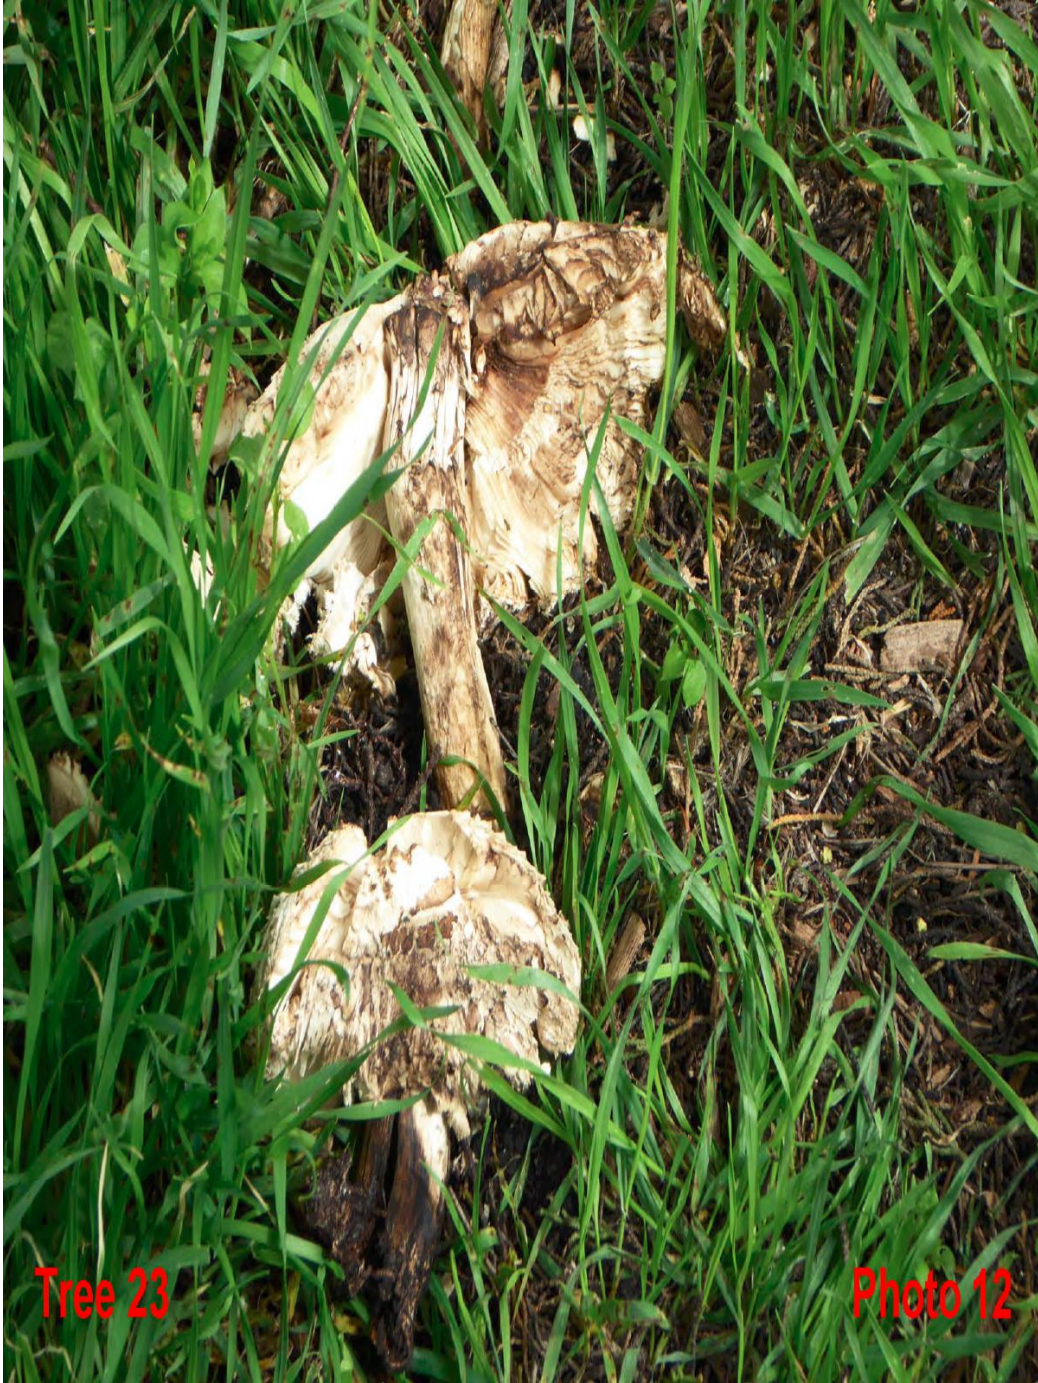
**Photo 12. Mushrooms near tree #23**

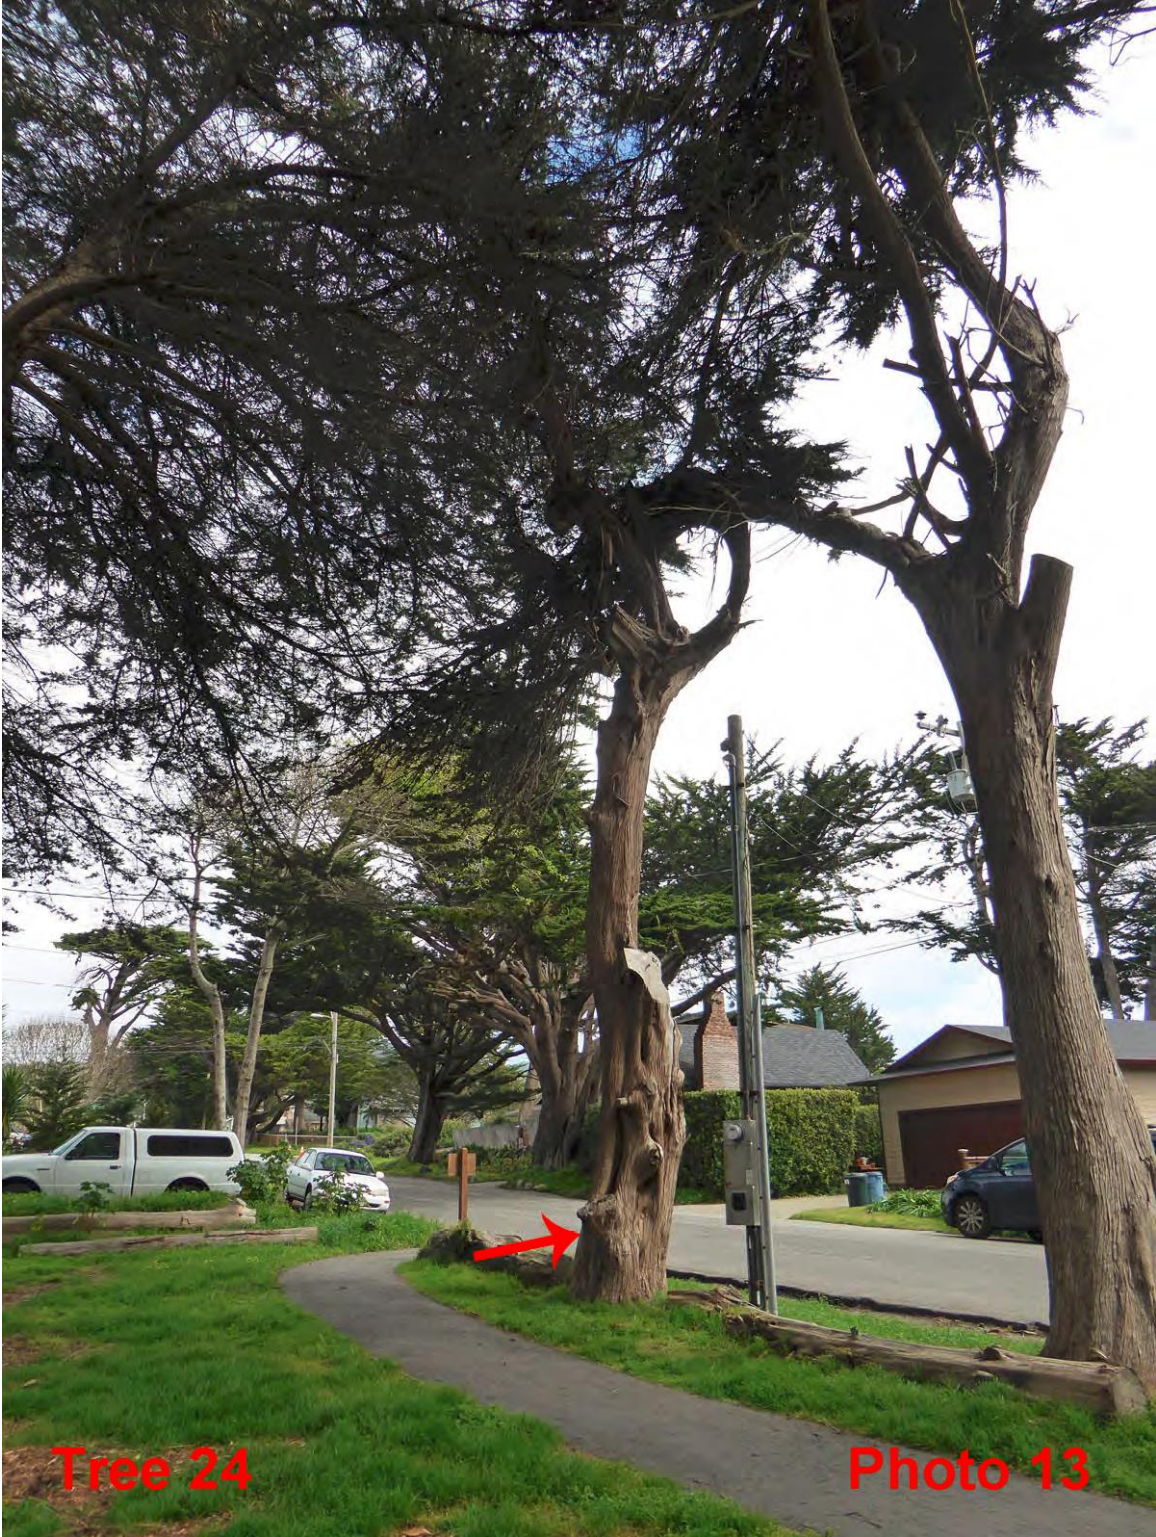
Two very large co-dominant stems were removed on the street side (south through east) of this tree. Sounding with a mallet did not detect decay associated with these areas, except for a slight hollowness on the north side. The tree is generally shorter than others along California Avenue, but is still a big tree and has a lean toward and over the street, high voltage wires, and neighboring houses across the street. Resistance drilling was used to test the location on the north side, and solid wood was found to a depth of 10 inches. More than half of the trunk is likely dead in a joined area that includes where the two very large co-dominant stems were removed. The wood is not currently extensively decayed, but the tree is likely to have several large, dead roots below this area. As the roots decay, the likelihood of uprooting failure will increase over time. It is probable that this tree will uproot in the near future.

**Photo 13. Tree #24 on NE corner of lot**

Removal of this tree is recommended.
