**COUNTY OF SAN MATEO  
PLANNING AND BUILDING DEPARTMENT**

**SUBJECT:** EXECUTIVE SUMMARY: Consideration of a Coastal Development Permit (CDP) to: 1) allow the “after-the-fact” placement and retention of 24 warning signs to keep the public away from hazardous bluff tops; 2) make repairs to an access ramp leading down from the bluff top; and 3) allow the “after-the-fact” removal of five Monterey cypress trees that were hazardous, at various locations within the Fitzgerald Marine Reserve and the Mirada Surf West County Park, in the unincorporated Moss Beach and El Granada areas of San Mateo County. This project is appealable to the California Coastal Commission.

# TREE RISK ASSESSMENT SUMMARY REPORT

April 2017

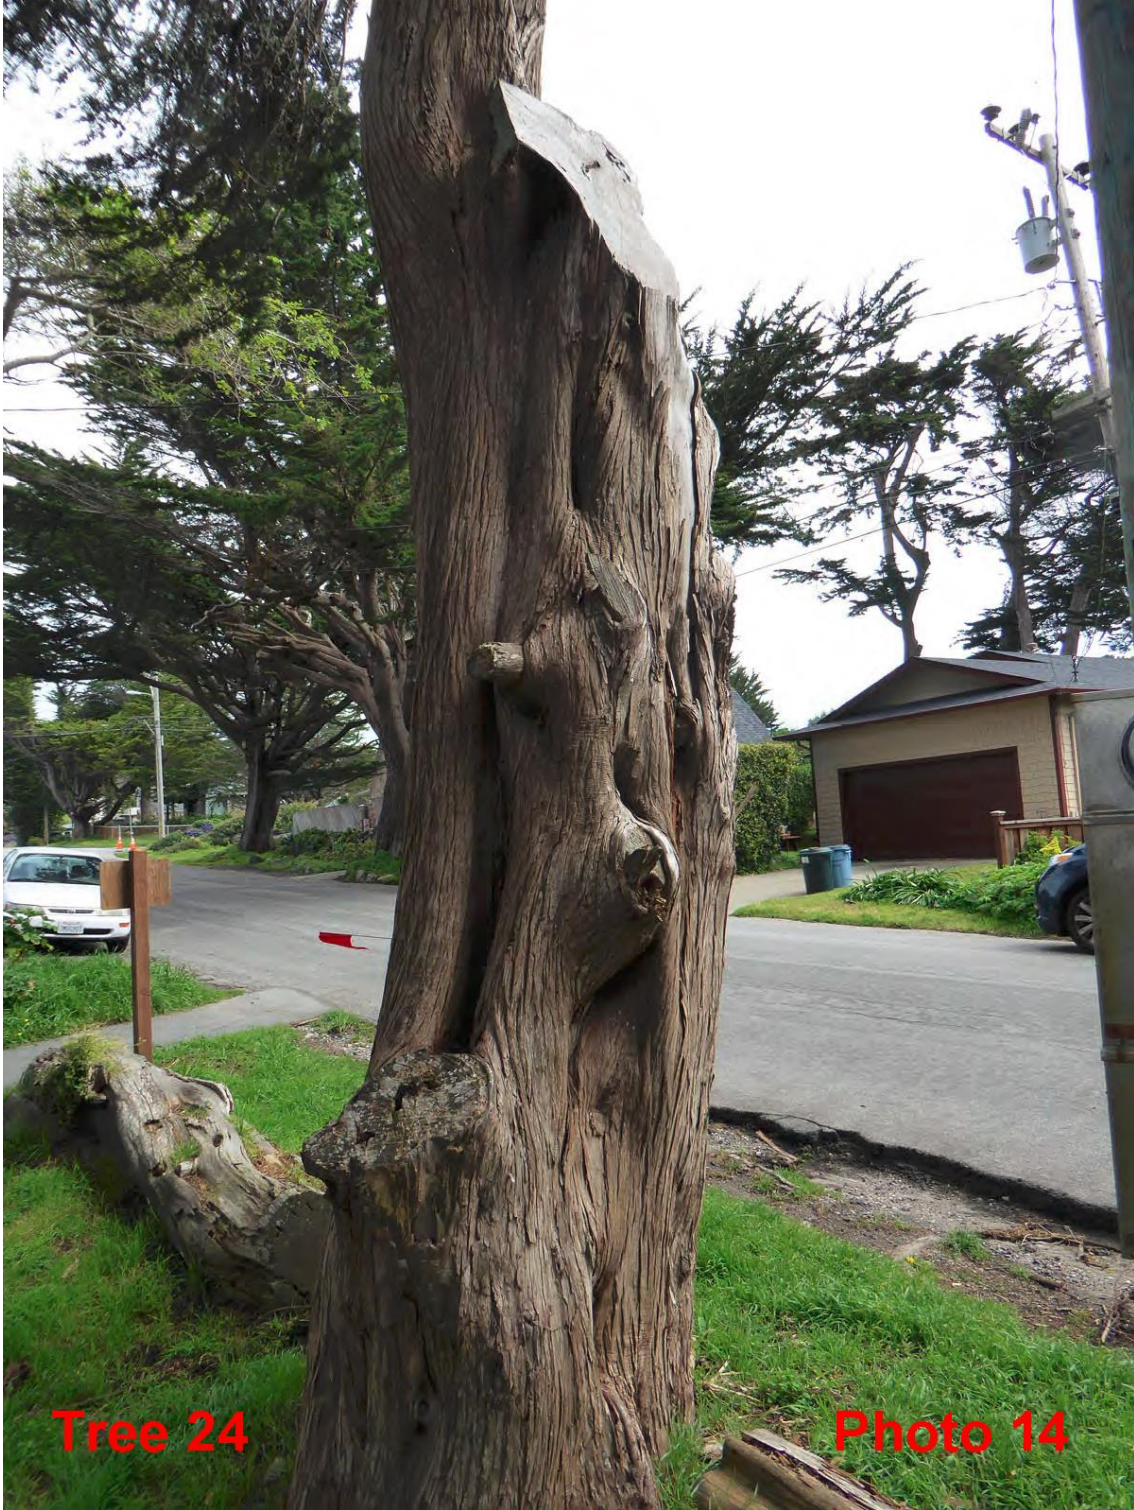
Two very large co-dominant stems were removed on the street side (south through east) of this tree. Sounding with a mallet did not detect decay associated with these areas, except for a slight hollowness on the north side. The tree is generally shorter than others along California Avenue, but is still a big tree and has a lean toward and over the street, high voltage wires, and neighboring houses across the street. Resistance drilling was used to test the location on the north side, and solid wood was found to a depth of 10 inches. More than half of the trunk is likely dead in a joined area that includes where the two very large co-dominant stems were removed. The wood is not currently extensively decayed, but the tree is likely to have several large, dead roots below this area. As the roots decay, the likelihood of uprooting failure will increase over time. It is probable that this tree will uproot in the near future.

**Photo 14. Drill site marked with red flag on tree #24**

Removal of this tree is recommended.

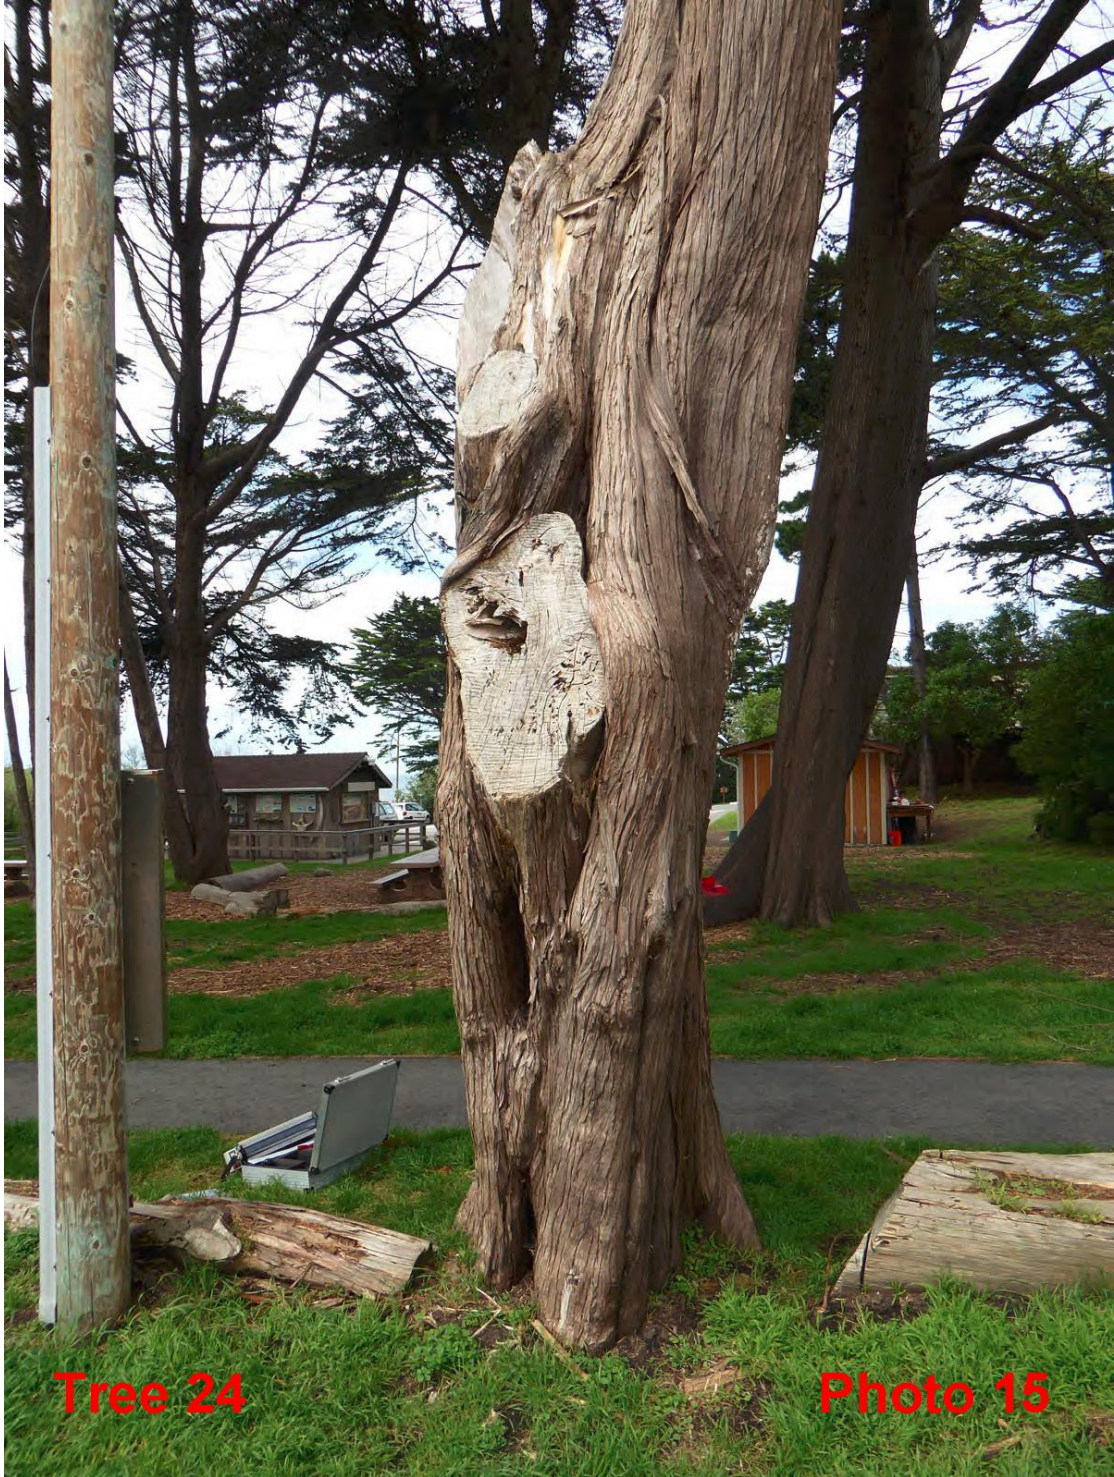
Photo 15

Photo 15. Dead trunk tissue of tree #24

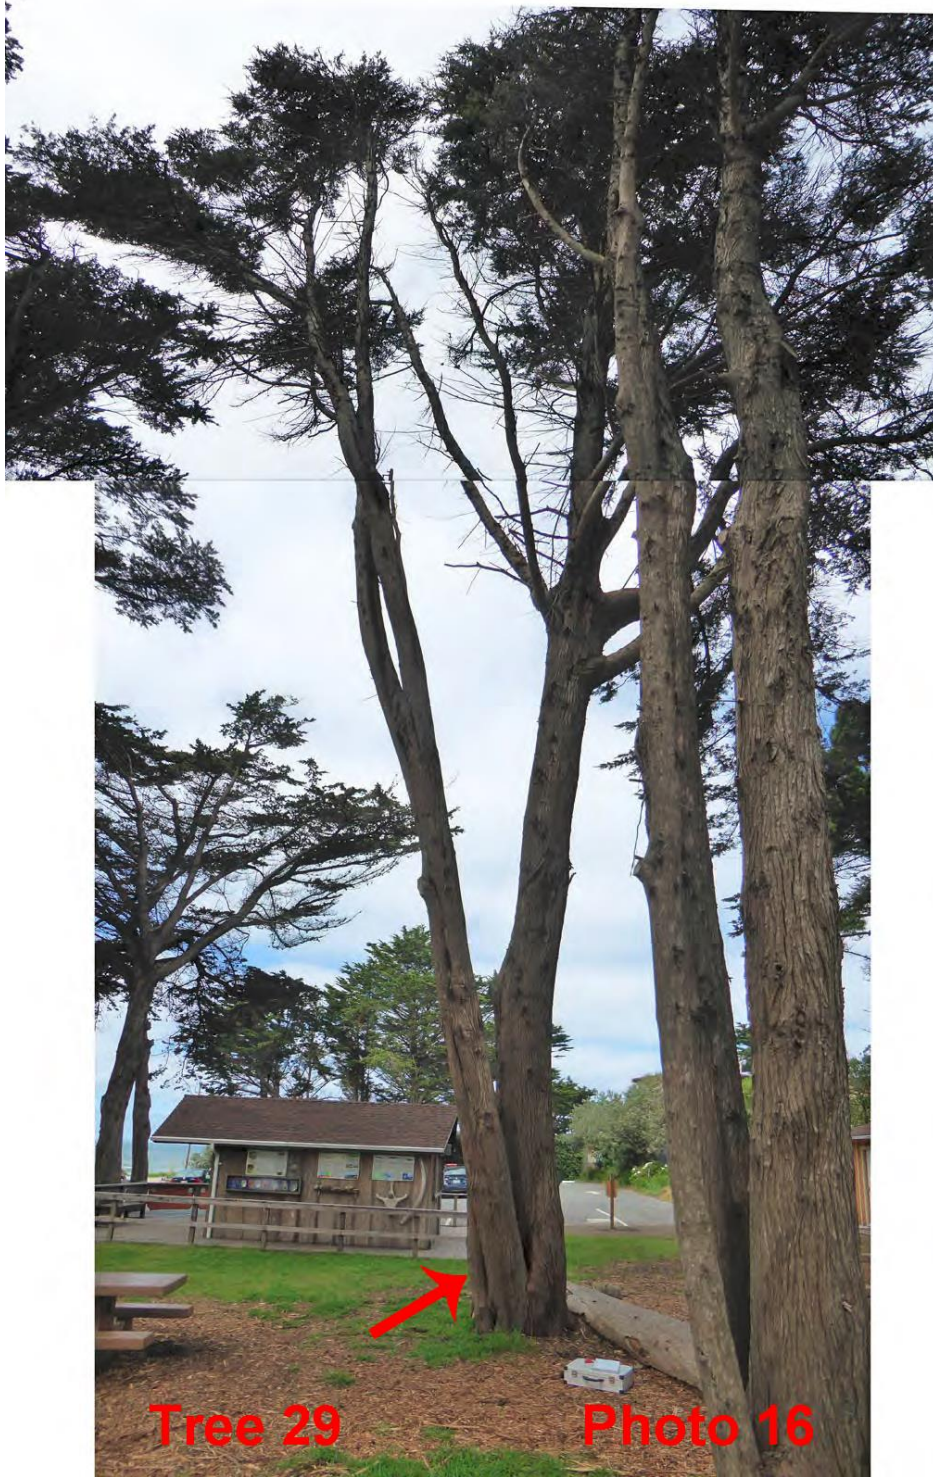
This tree has a slightly dominant more vertical trunk, and a very low branching somewhat codominant trunk with a lean toward the southeast. The juncture is narrow with a large bark inclusion. The more vertical trunk has a low live crown ratio of about 30 percent, and the leaning co-dominant trunk has a very low live crown ratio of less than 10 percent. An adjacent tree was recently removed and this leaning trunk is now exposed to wind. The Level 2 assessment of this tree noted 'possible decay' at the stem juncture. Sounding with a mallet did not detect any hollow area, and as each new wound will have the potential to create new decay, invasive methods are not used when visual or other noninvasive techniques are conclusive. For this reason, no resistance drilling was used on this tree.

Because of the very low live crown ratio, large bark inclusion and recent removal of an adjacent tree, this leaning trunk is in danger of failing at any time and would strike the picnic tables.

**Photo 16. Poor trunk structure of tree #29 next to picnic table**

Due to the age and condition of this tree, cabling will most likely be ineffective. Removing the leaning stem will make the other stem more prone to failure. Moving the picnic tables will reduce the likelihood of a stem failure striking the picnic tables, however total exclusion of pedestrians is not feasible. Full removal is recommended for this tree.

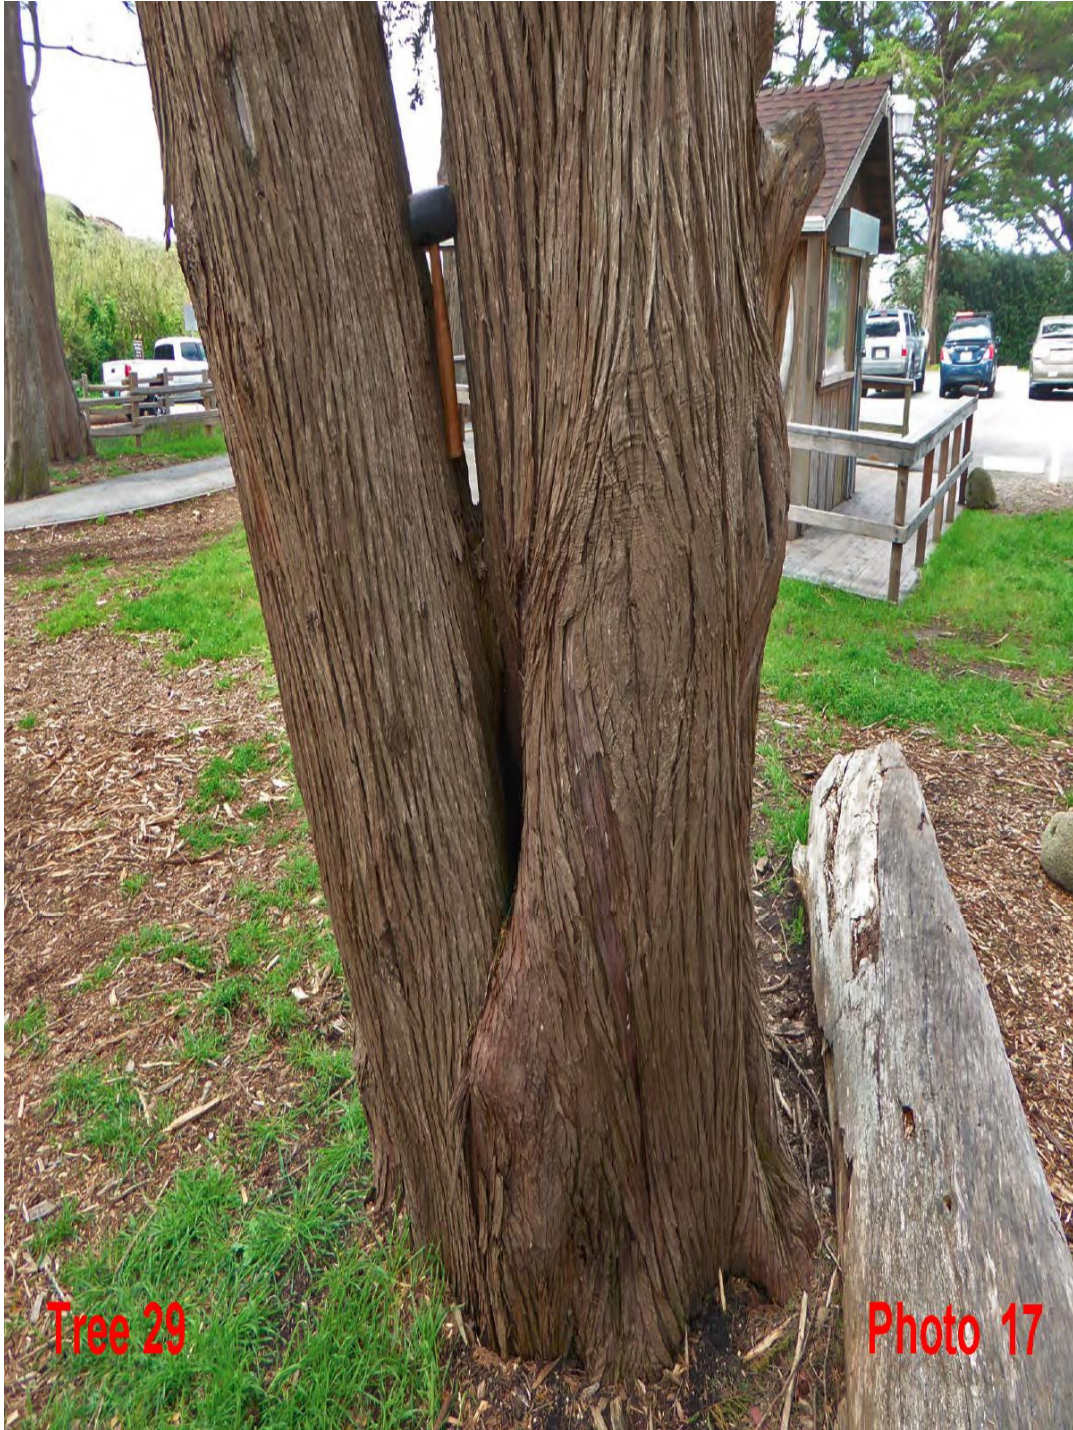
**Photo 17. Narrow stem attachment with bark inclusion of tree #29**

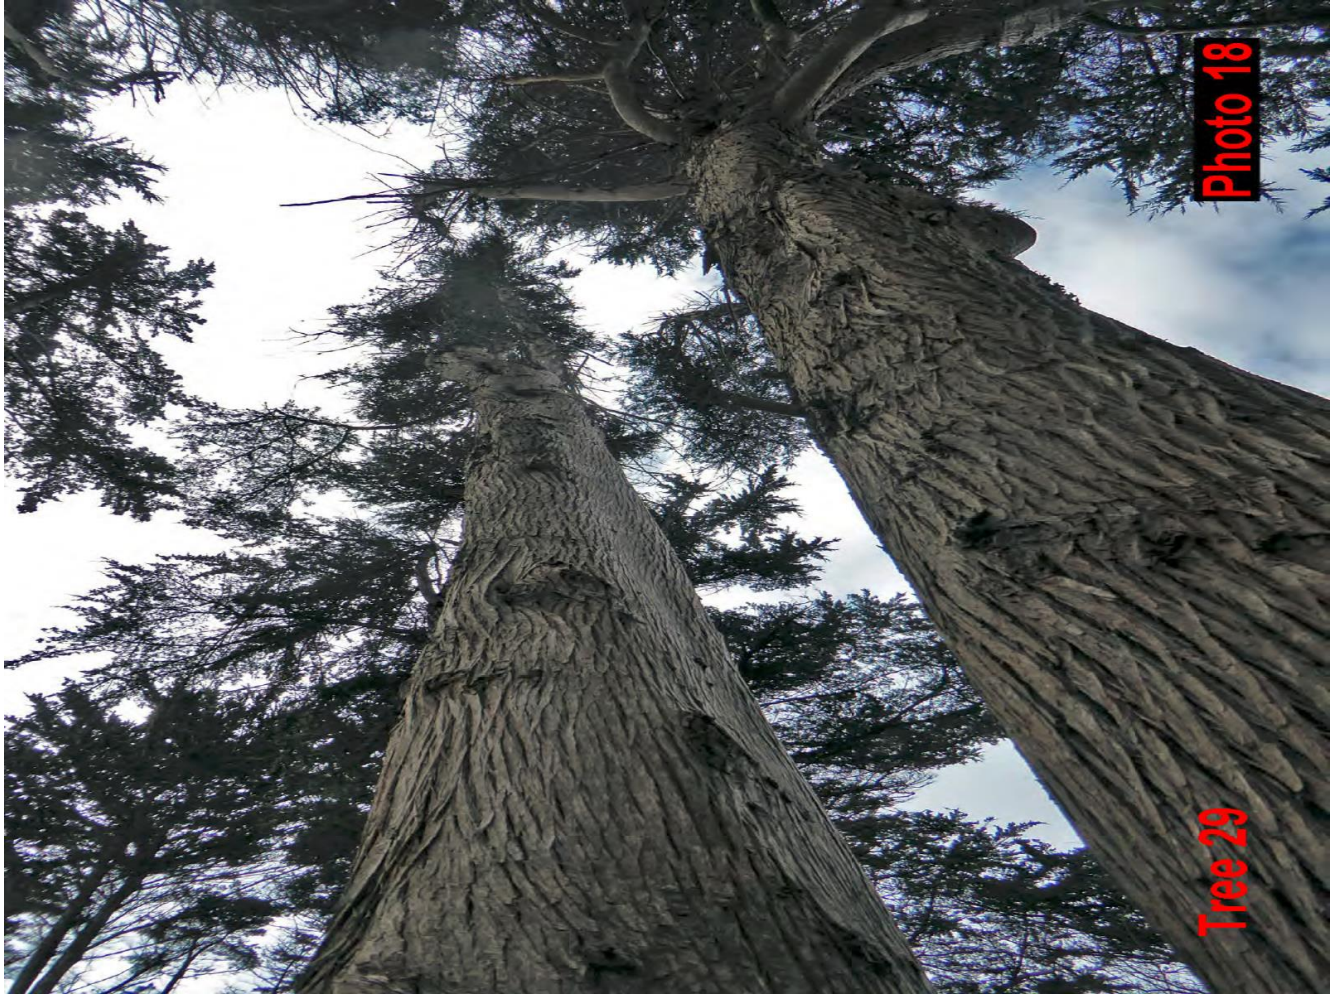
**Photo 18. Stems with low live crown ratio of tree #29**
