# GEOTECHNICAL DATA REPORT

ANIMAL CARE SHELTER  
12 AIRPORT BOULEVARD  
SAN MATEO, CALIFORNIA

**March 9, 2015**

**Project No.**  
11780.000.000

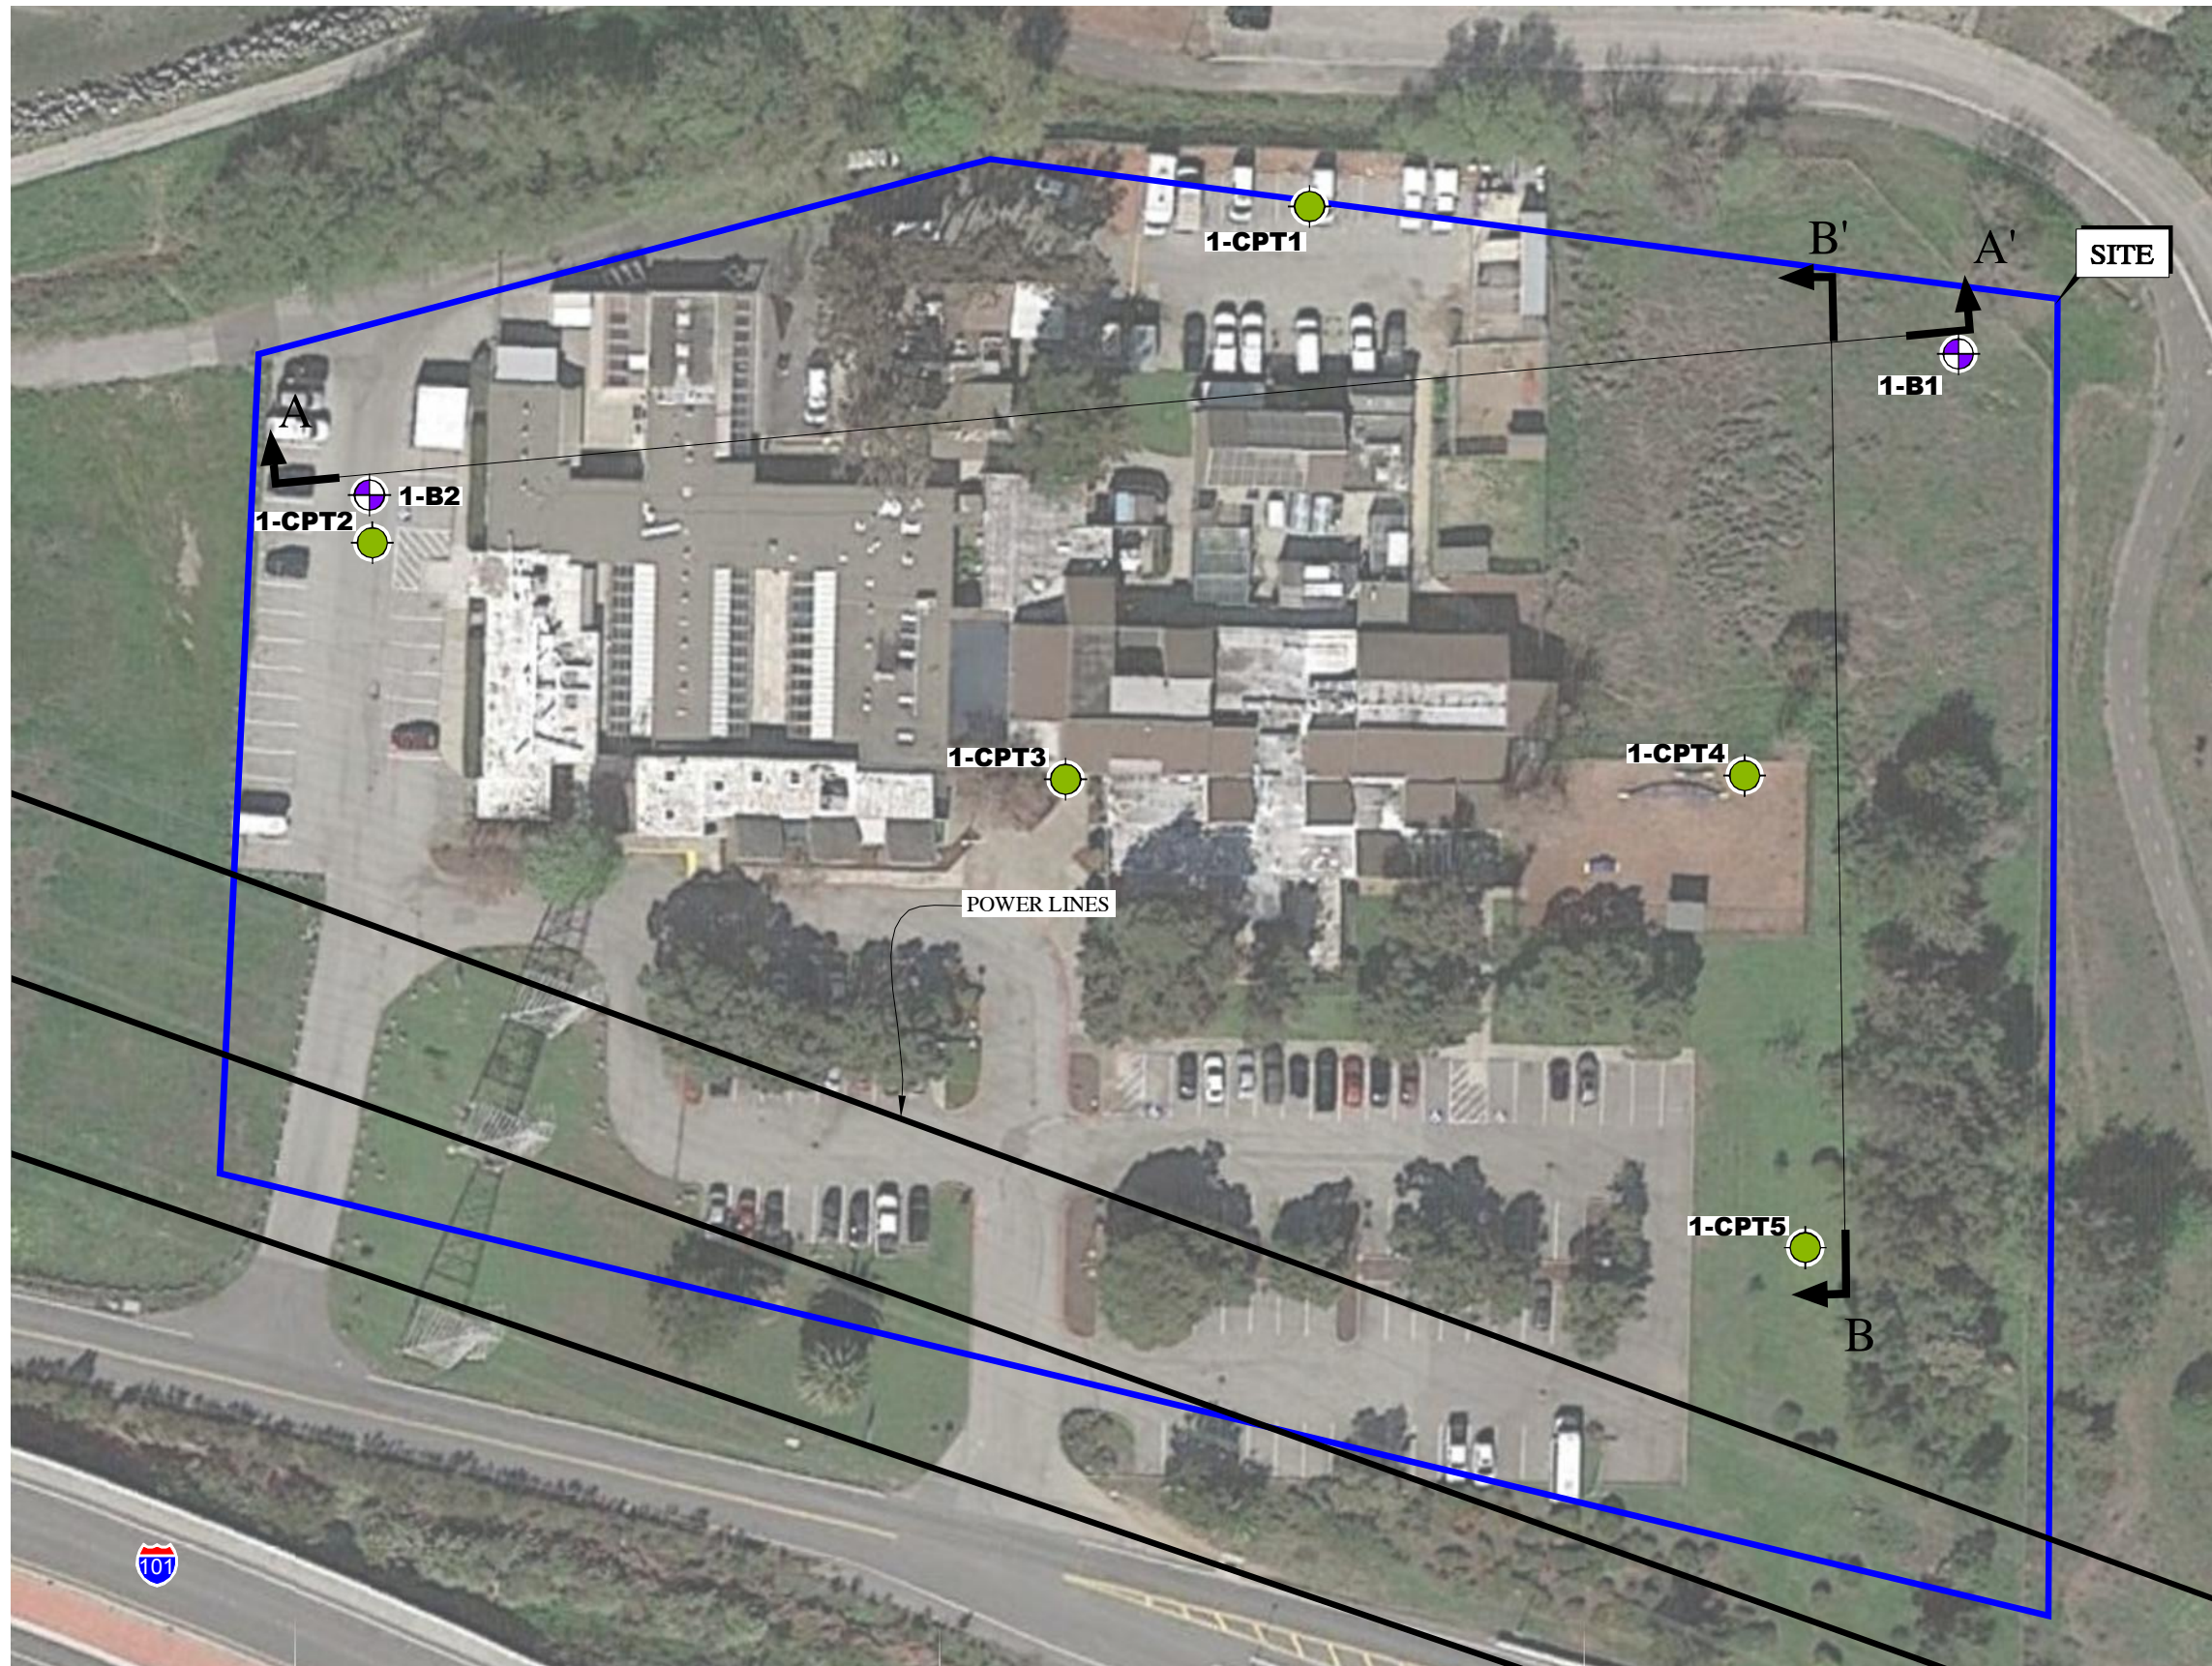
Figure 2 is a Site Plan that shows approximate site boundaries, our exploratory locations, geologic cross section locations, and other pertinent information. The project site is bounded by Airport Boulevard and Highway 101 to the south, Poplar Creek Golf Course to the east, the San Francisco Bay Trail and San Francisco Bay to the north, and vacant land to the west.

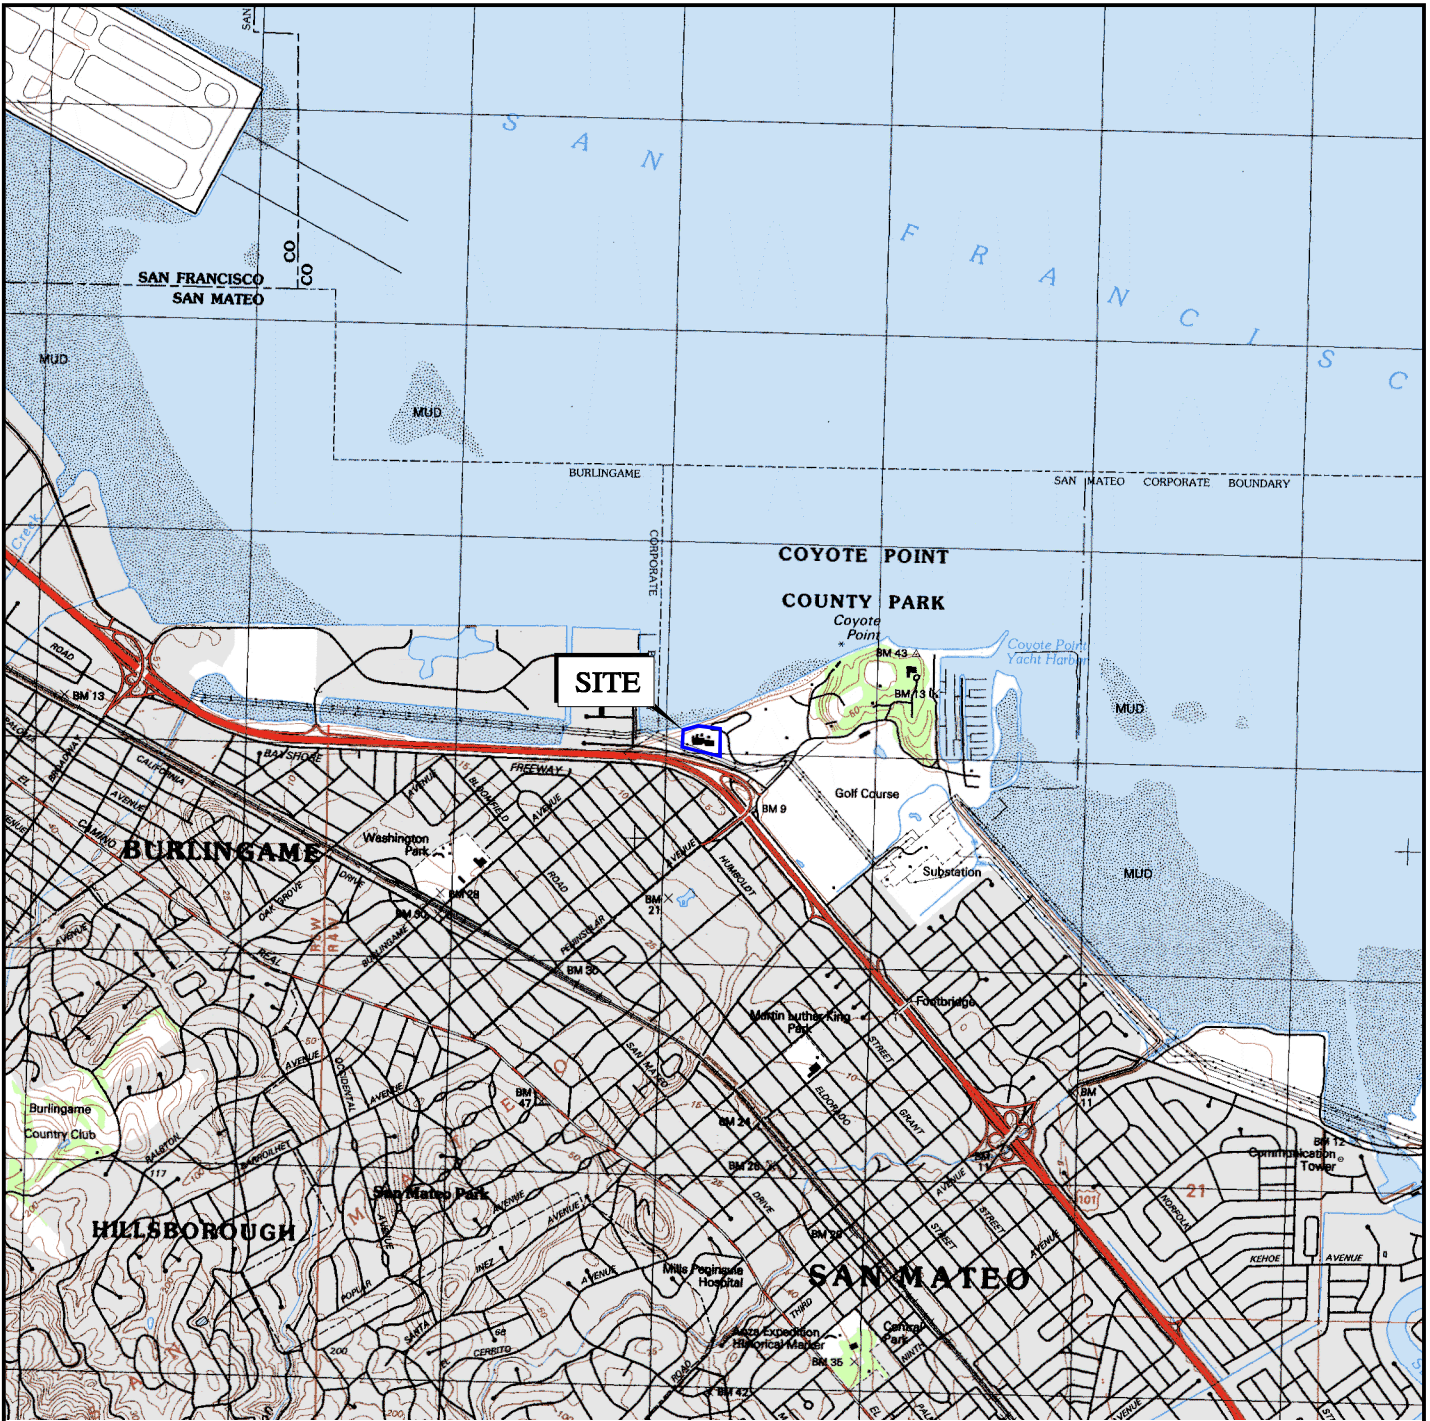
FIGURE NO.  
**6**

Figure 6 presents a recent topographic map of the site.
