**COUNTY OF SAN MATEO  
PLANNING AND BUILDING DEPARTMENT**

**SUBJECT:** EXECUTIVE SUMMARY: Consideration of a Coastal Development Permit and Planned Agricultural District Permit to drill a domestic water well, and install a water line and water tank to serve an existing single-family residence. The domestic well will replace the natural spring water box that was previously used as a source of water for the residence. The property is located at 20080 Cabrillo Highway in the unincorporated San Gregorio area of San Mateo County. The project is appealable to the California Coastal Commission.

County File Number: PLN 2019-00385 (Midpeninsula Regional Open Space District)

Toto Ranch  
Tunitas Creek Open Space Preserve  
Rangeland Management Plan

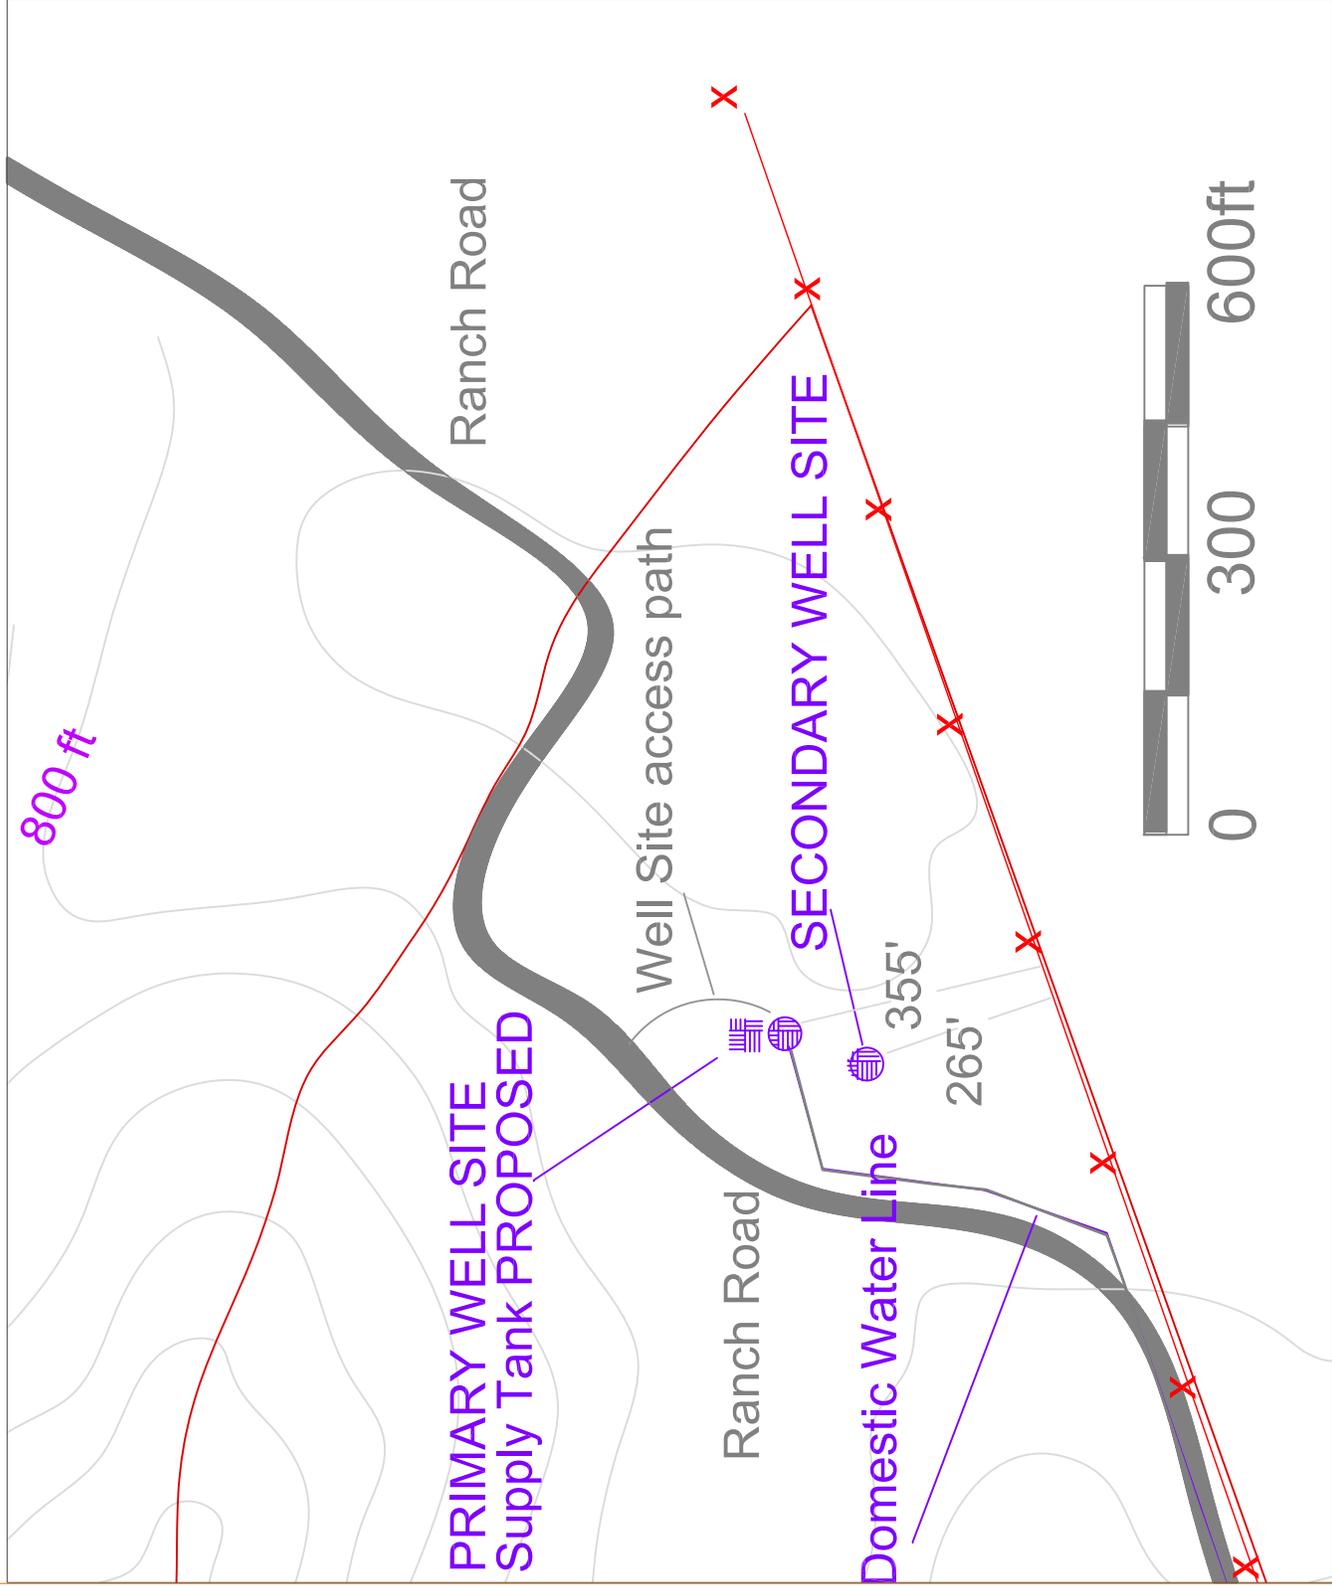
<b>GPS COORDINATES</b>	
<b>ACCESS PATH</b>	LAT 37.34882754 LONG -122.37422165
<b>PRIME WELL SITE</b>	LAT 37.34768333 LONG -122.37402351
<b>SECONDARY WELL SITE</b>	LAT 37.34744977 LONG -122.37424185

**WELL NOTES:**

- New supply tank low profile 1500 gallon at well site.
- Well powered by solar pump with battery back up.
- New well line to be connected from new well site to existing Domestic storage tanks near house.
- Estimated new water pipe line 1.5"-2" diameter 4000 ft in length.
- Well site is approximately 860 feet in elevation, existing storage tanks are approximately 500 feet in elevation.
- Drill tailings to be spread around current proposed well site in an area less than 200 square feet.

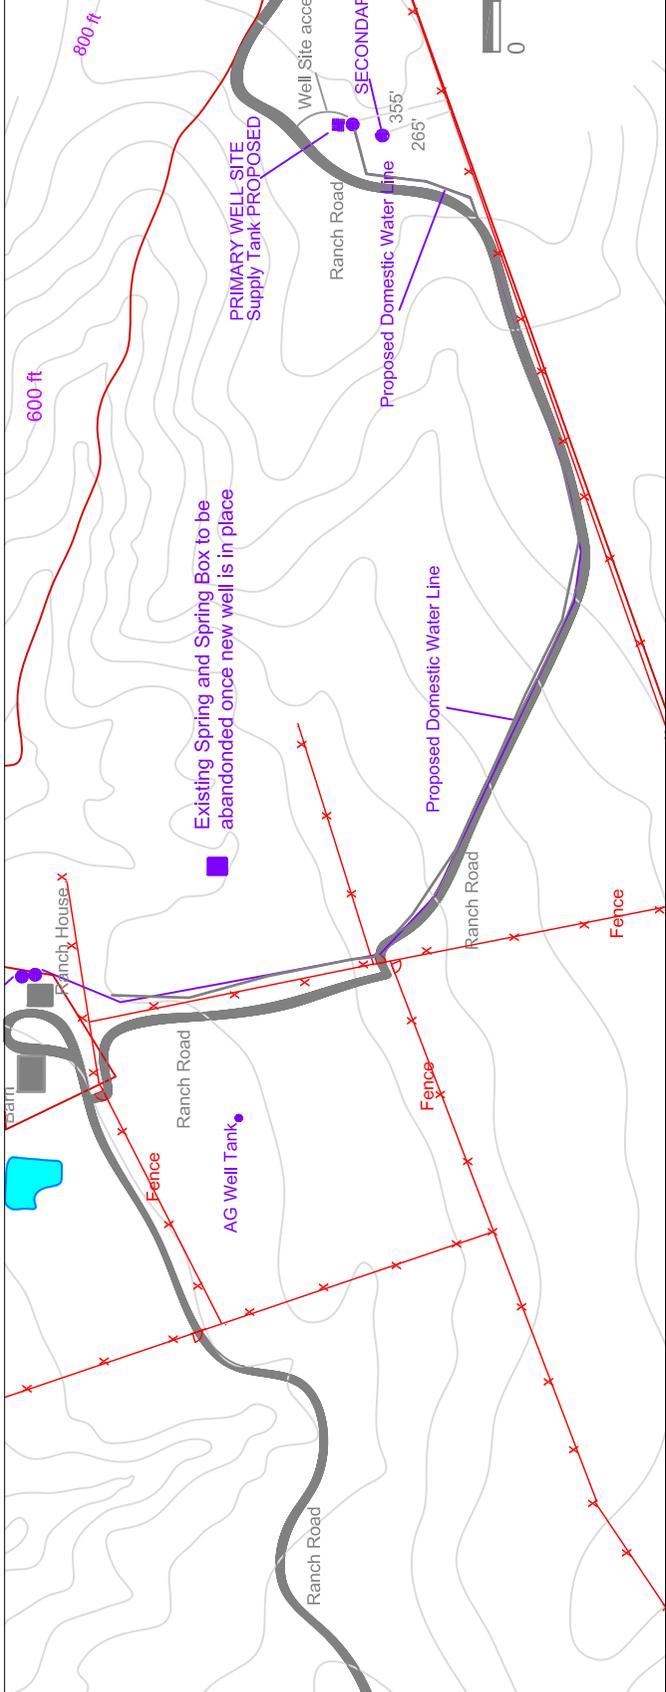
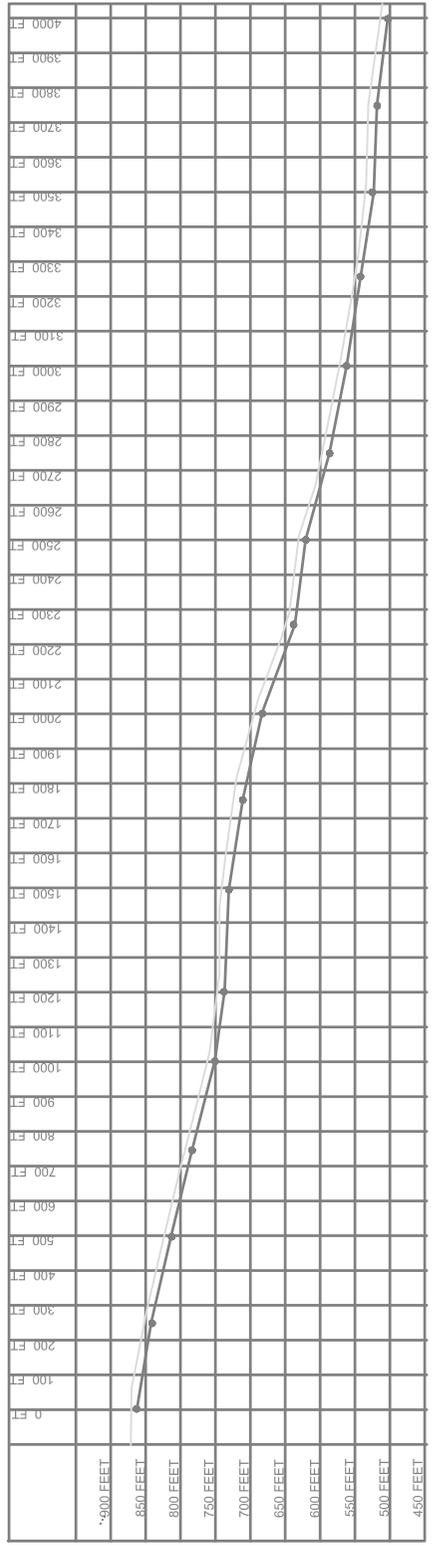
<p><b>Midpeninsula Regional Open Space District</b>          330 Distel Circle Los Altos CA 94022          office: 650.691.1200</p>	<p><b>Tunitas Creek Open Space Preserve</b>  <b>Domestic Well Installation</b>          20080 Cabrillo HWY South Half Moon Bay, CA 94019          SAN MATEO COUNTY, CA</p>	<p>Date: 09/01/2019          Drafted: OKS III          Project contact: Aaron Peith          APeith@openspace.org          OSmith@openspace.org          Revision Date:</p>	<p>APN: 081060100          ZONING: PAD/CD</p>	<p>Pipeline  <b>Detail</b>          4</p>
---	--	---	---	---

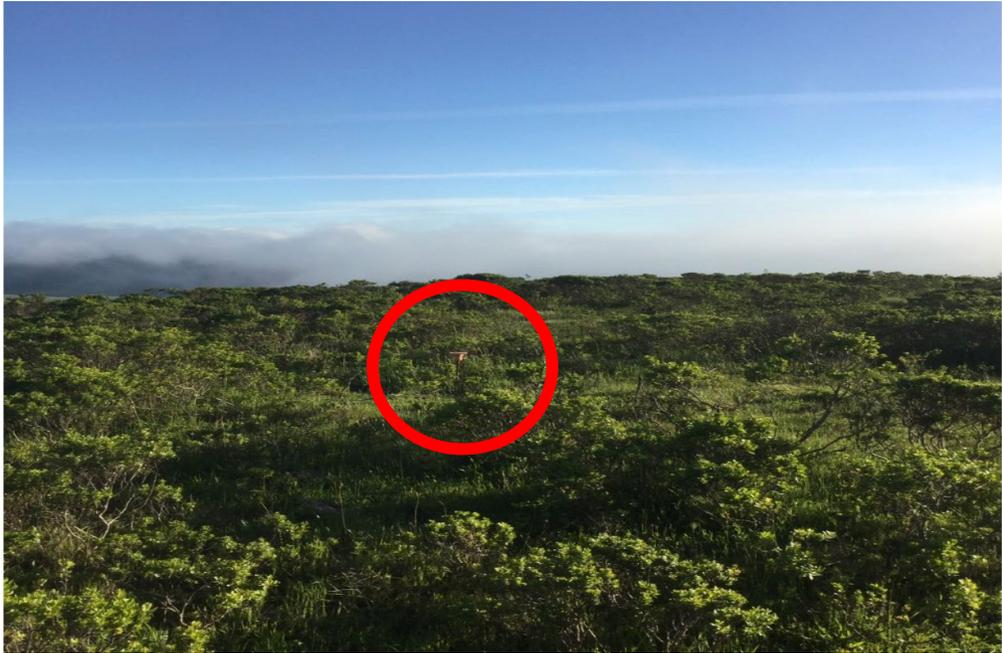
Well staked drill point location

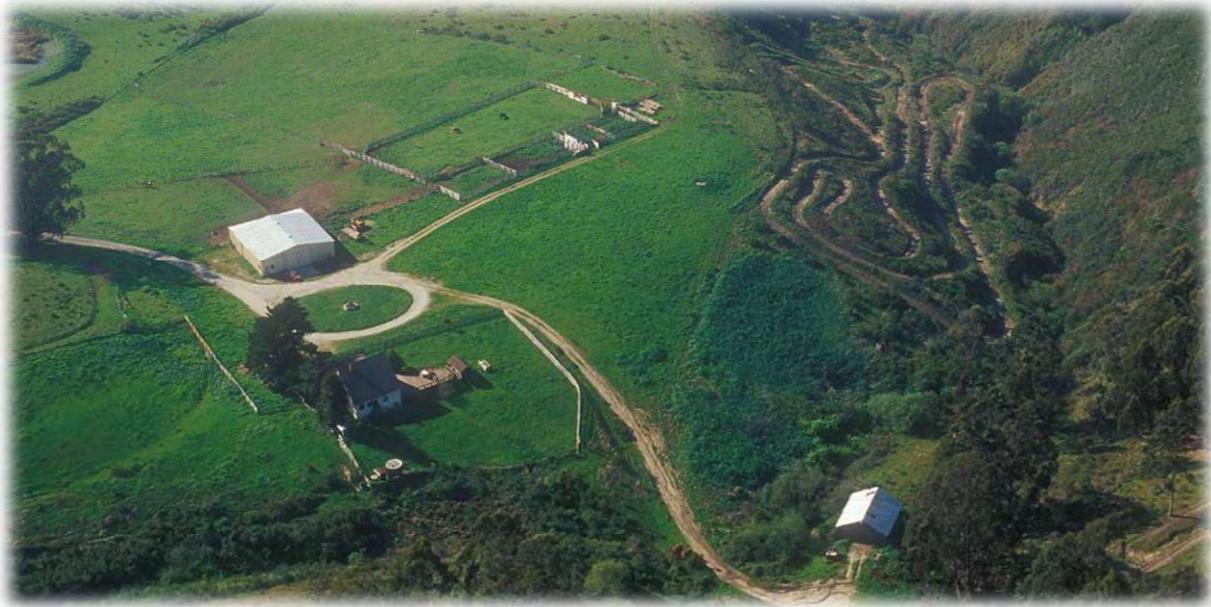
**Figure-2:** Aerial view of the Agricultural Lease area and associated buildings including hay barn (bottom right), residence (center), metal-sided shop/barn (top left) and the livestock corral (top center).

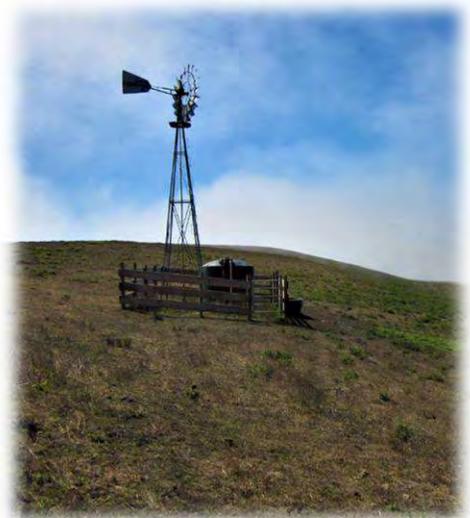
**Figure-5:** Windmill powered well located on the ridge along the southern property boundary. Well water is pumped into storage tanks and then flows via gravity to the Agricultural Lease area where water is provided to livestock in a number of water troughs.

Residential water for the Agricultural Lease area is provided via a natural spring located on the ridge to the south of the Agricultural Lease area. Refer to Toto Ranch Water Infrastructure Map (Exhibit-E).

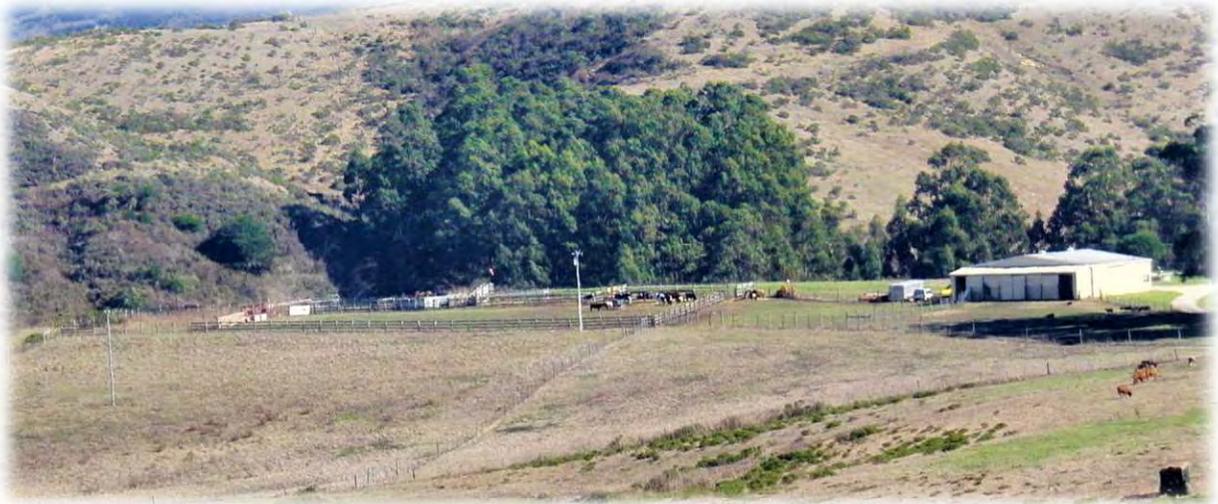
**Figure-6:** Wooden livestock corral with metal-sided barn/shop building (right). Small pastures or flight pens are ideal for running sheep, goats and other small livestock (foreground).

A set of wood livestock corrals are located within the Agricultural Lease area used for processing and shipping/receiving livestock. The corrals are old but in fair condition and function adequately for the existing livestock operation on the Ranch. The corral is accessible year-round by truck/trailer and semi-trucks via an all-weather gravel road.

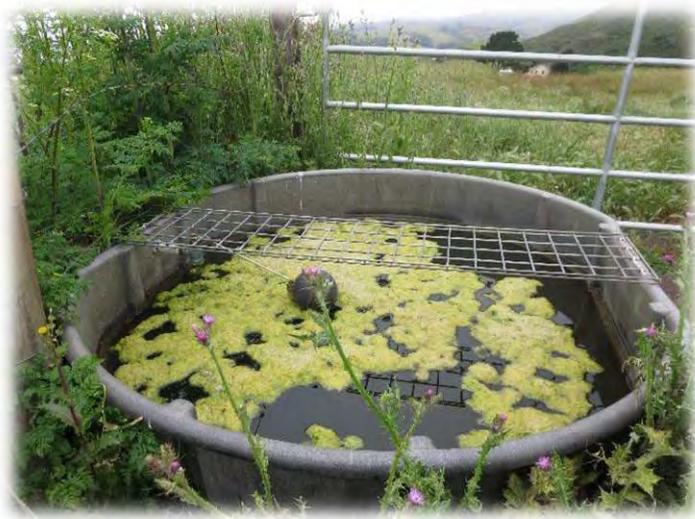
**Figure-7:** A plastic water trough in the pasture south of the residence. Note the invasive thistle and poison hemlock growing around the trough. These plastic troughs are designed to be temporary and should be replaced with galvanized or concrete troughs in grazed pastures. A wildlife escape ramp is missing from this trough and should be installed to protect wildlife that may fall into the water.

Water is provided to livestock primarily through a number of plastic, concrete, and galvanized water troughs located within the Agricultural Lease area and nearby pastures. All water troughs should be equipped with wildlife escape ramps to prevent entrapment of wildlife. Water is primarily supplied by a windmill/well and solar pump/well. Water is collected in one 2,500 gallon and two (2) 5,000-gallon water storage tanks near the wells and flows via gravity to the Agricultural Lease area before distribution to the troughs in/around the Agricultural Lease area.

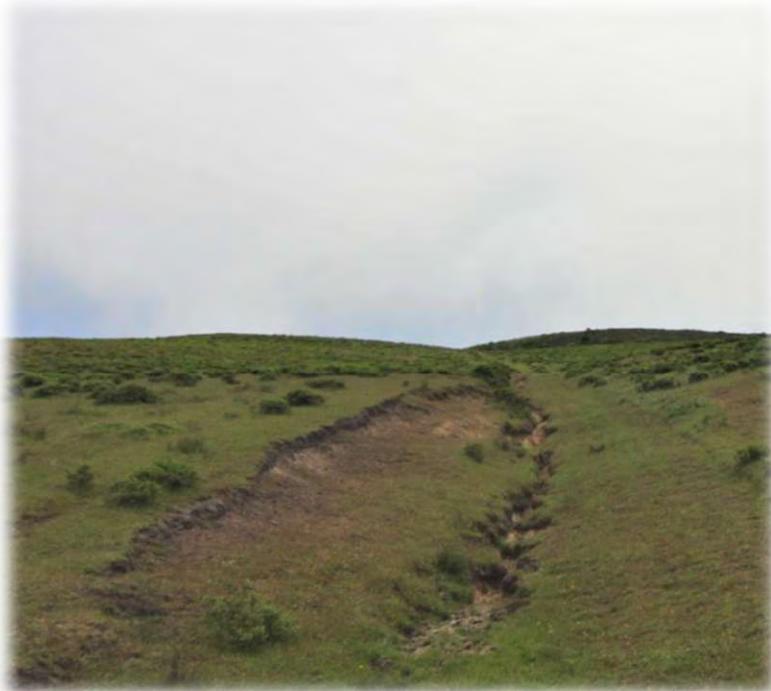
**Figure-8:** Gully/rutting activity along an insloped road just south of the Agricultural Lease area. Large gully caused by surface water flow during winter storm events. Road should be re-graded and water diversion points installed to relieve surface flow to protect the integrity of the road.

In general, roads on the Ranch are in fair to good condition, though minimally maintained. Most Ranch roads are minimally graded with native vegetation ground cover present, often times delineated by vehicle tracks in the vegetation from continued use by the tenant. While many of the roads are stable and in good condition, several areas are impacted by active gullying/rutting from surface water flow. Winter rains will continue to cause damage to the road surface and potentially transport sediment into local streams. In addition, a number of roads, particularly along the back half of the Ranch, are overgrown with brush creating hazardous access conditions for vehicles and pose a fire risk from vehicle ignition sources during hot dry conditions.

A ranch road beginning in the Agricultural Lease area and looping around to the back half of the Ranch is impassible due to a large seep/spring creating a mud bog. The road was historically accessible but has not been used in several years. If road repairs are undertaken in this location, (installation of culvert or ford crossing, road reroute, or other) engineering oversight should ensure correct sizing and placement of erosion control features, to allow access and protection of wetland features associated with the spring.

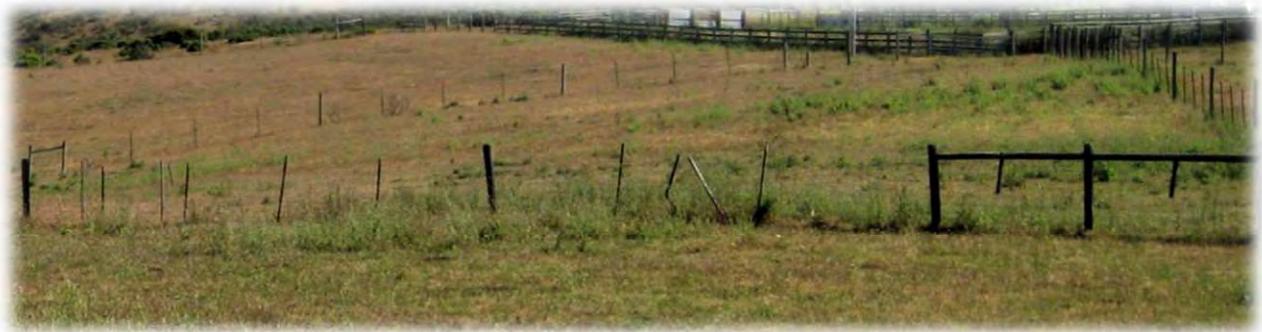
**Figure-9:** Sample of New Zealand style smooth wire fencing on the Toto Ranch. The high tinsel smooth wire is susceptible to damage and often breaks. Most fences on the ranch are older and in varying condition.

The grazing tenant installed a Management Intensive Grazing (MIG) system consisting of approximately 60 small grazing paddocks, constructed of temporary electric fencing. The MIG, located west of the Agricultural Lease area, is designed for high-intensity, short duration grazing as cattle are regularly rotated between paddocks during the “green” growing season, typically January through June. No notable resource management benefits have been derived through use of the MIG system.
